SHERINGHAM POINT LIGHTHOUSE

RESTORATION
2015 - 2019

Final Report
&
Documentation

Sheringham Point Lighthouse
Preservation Society

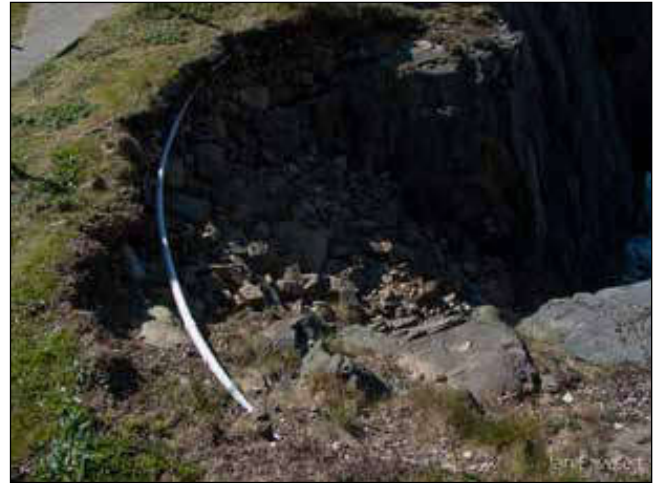
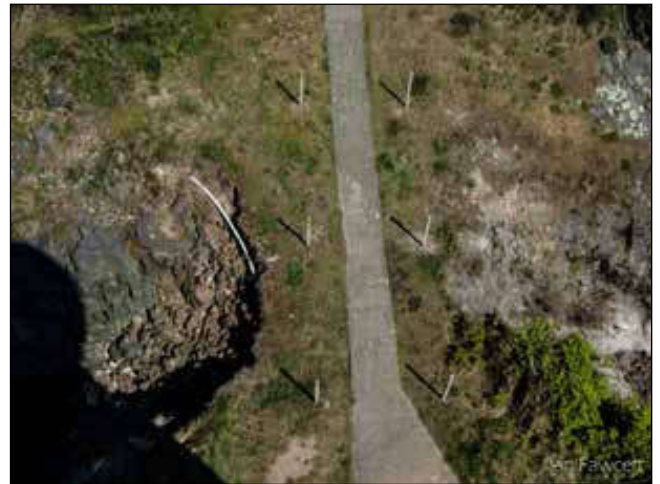
Image 3 (top left): erosion on the east side of the causeway

Image 4 (top right): erosion on the west side of the causeway

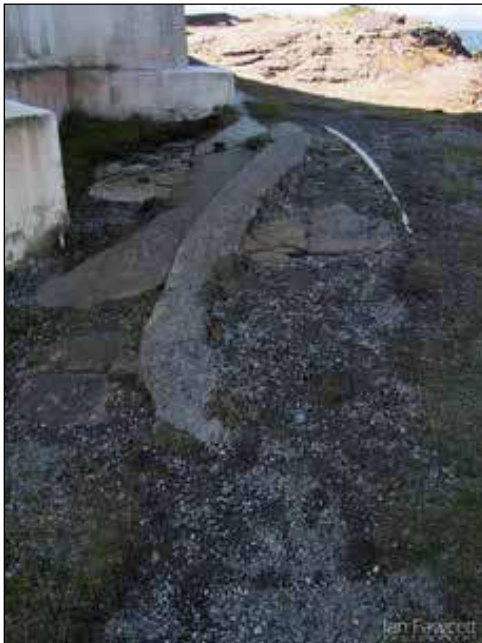
Image 24 (left): previous above-ground asphalt covering - not to code

Upon reaching the structures, we had to find a new path inside the buildings to connect to the panel. The previous ingress (into the engine room) was no longer useable (due to inaccessibility and corrosion). We had the option of either drilling through the wall of the tower, or cutting a path across the concrete base of the engine room. Both options were not good, and would negatively affect the historic fabric of the structures. It was decided that the tower structure was of the greatest historical value and should not be compromised. Therefore a trench was cut into the concrete base of the engine room. Care was taken to ensure that this cutting was as minimal as possible. Once the conduits were laid, it was concreted over. New conduit was placed on the exterior of the west wall of the engine room, replacing the existing corroded conduit, and entered the engine room through two new holes drilled through the concrete block wall. The corroded conduit was removed and the entrance hole filled. (See following photographs).

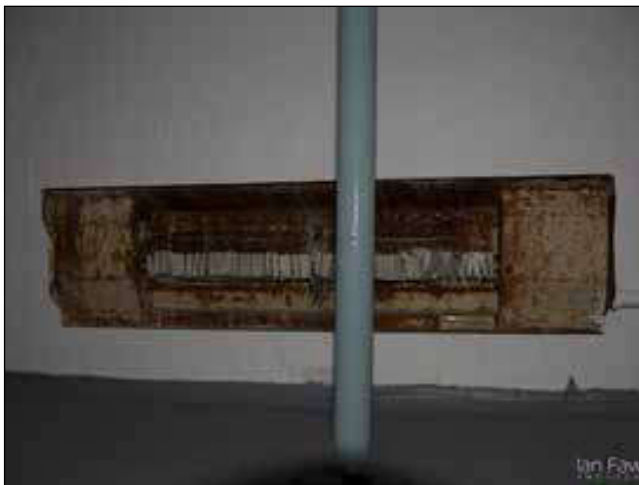
Image 35 (top left): previous, corroded baseboard heater in tower

The basic electrical fixtures in both the engine room and tower were corroded beyond usability and were replaced. This included overhead lighting (fluorescent) and baseboard heaters in the engine room, and wall -lights and baseboard heaters in the tower. Efforts to find exact replicas of these fixtures in reasonable working order were unsuccessful, so near-approximations were used. In addition protective steel cages were installed over the bare lightbulbs in the tower to ensure user safety. (See following photographs).

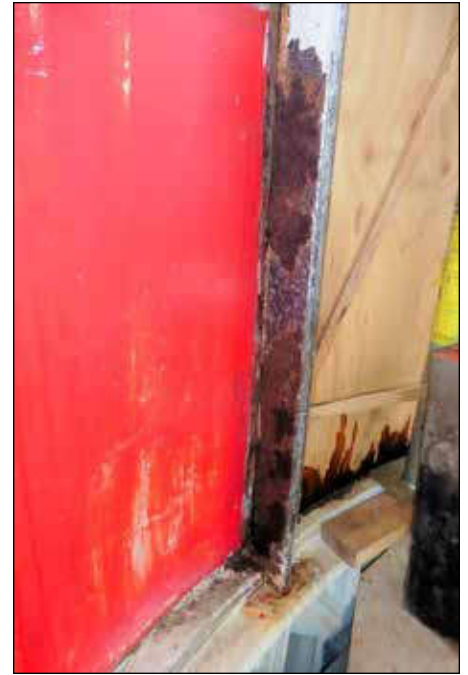
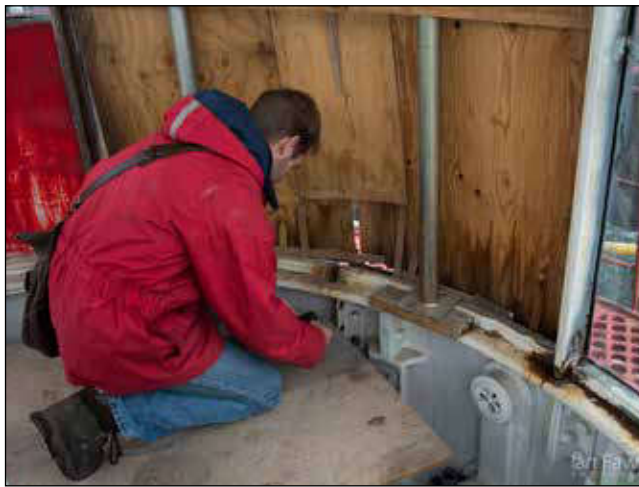
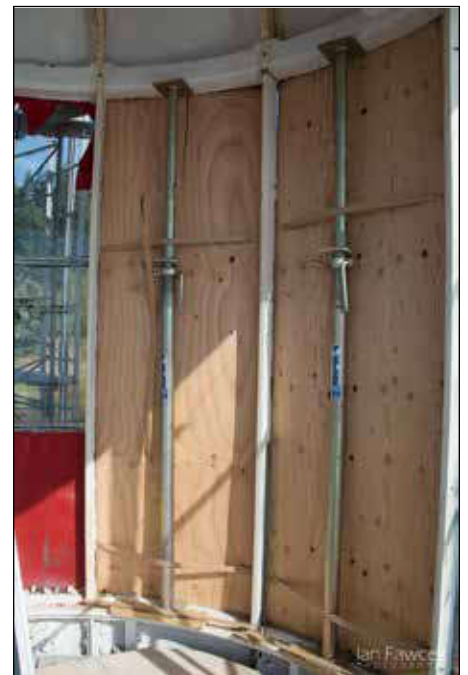
Image 39, 40 and 41 (top row): corrosion on lantern room mullions, prior to treatment

The removed mullion was taken to Smith Bros. Foundry and Machine Works, where it was cleaned to permit examination by John Dam. Fortunately the corrosion was found to be limited to the exterior of the mullion, and its structural integrity was sound. This meant that the remaining mullions (which were not as badly corroded as the test one) could be left in place, and just surface cleaned. This also meant that the strategy for restoration and, in particular, the window replacement, would be significantly simpler (and cheaper) in that no shoring would be required and all windows could be replaced at once. The removed mullion was later re-installed by welding it back together on site, with a small extension (about ½ inch) added to replace the material that had been cut away. (See following photographs).

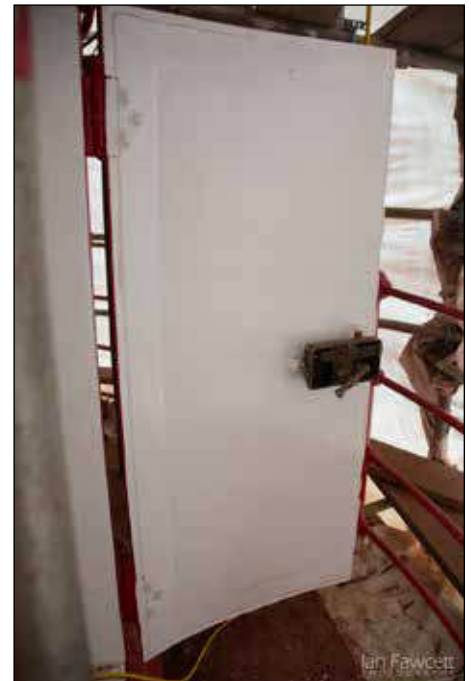
Image 65 (left): lantern room door interior, showing corrosion and beginning of separation of top panel from the rest of the door

The door was removed from its hinges and taken to Foggy Mountain Forge, where the work was completed (except the painting). The restored door was rehung in the lantern room, but it was found not to close properly, due to the rigidity of the new plate that had been attached. This required that it be removed again, returned to the forge where it could be slightly bent, and then rehung. It now fit relatively well, and it was decided to install some weather stripping around the edges to provide a better seal. The door was then painted along with the rest of the lantern room. (See following photographs).

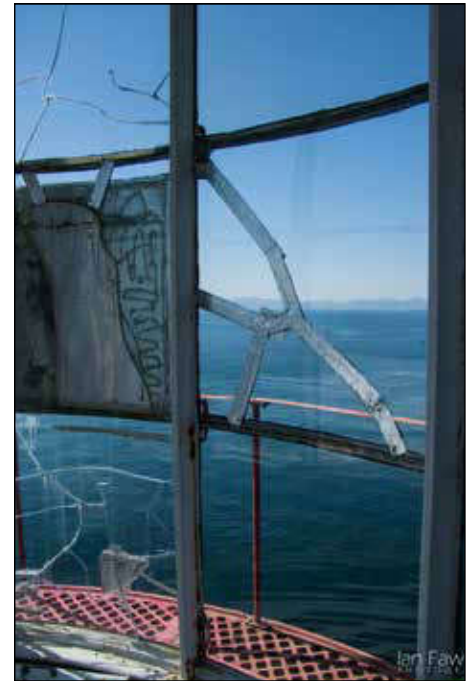
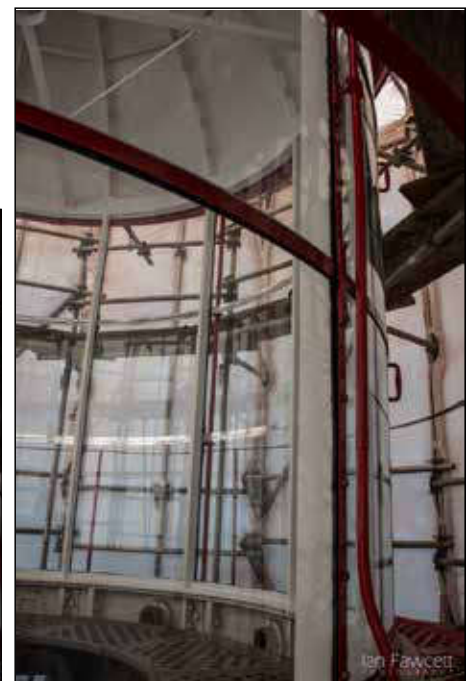
Image 71 (centre right): original mounting straps, too narrow

Image 72 and 73 (bottom row): replacement lantern room windows installed, with replacement, wider, mounting straps

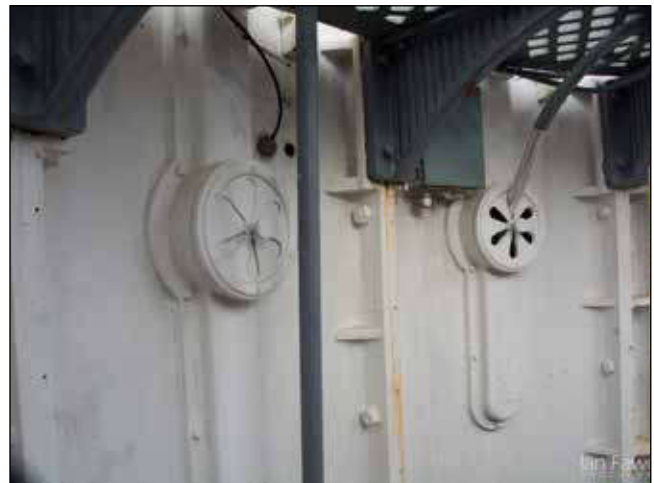
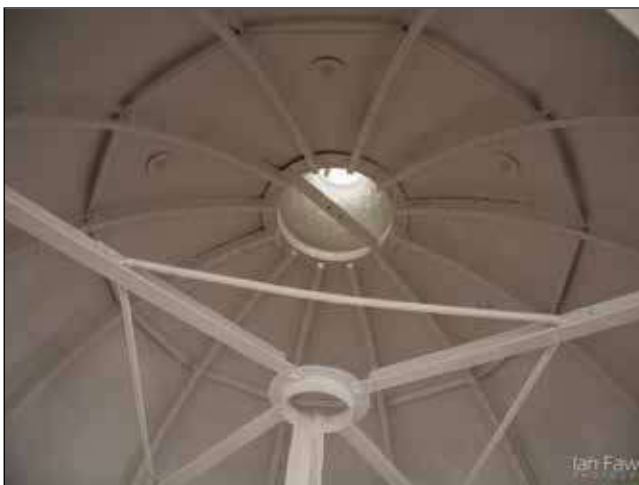
Image 74 and 75 (top row): original condition of lantern room interior, showing some corrosion

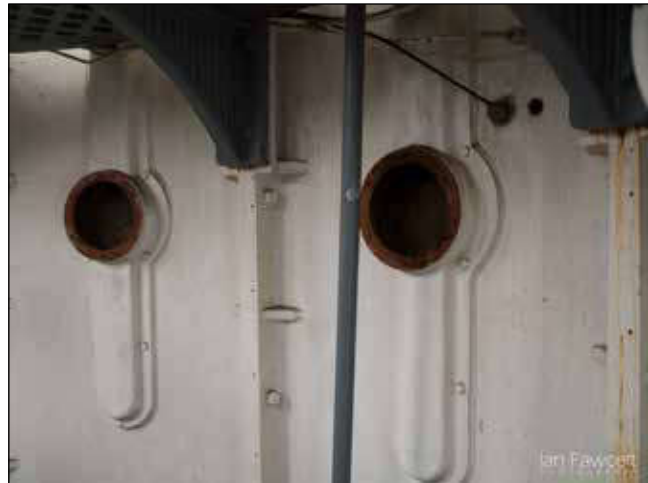
Image 78 (top left) and 75 (previous page): show vents in original condition

Rather than repaint the (now) cleaned and functional vents, it was decided to leave them as bare brass, and reinstall them in that condition, both to improve their functionality and to show them more clearly in the lantern room. (See following photographs).

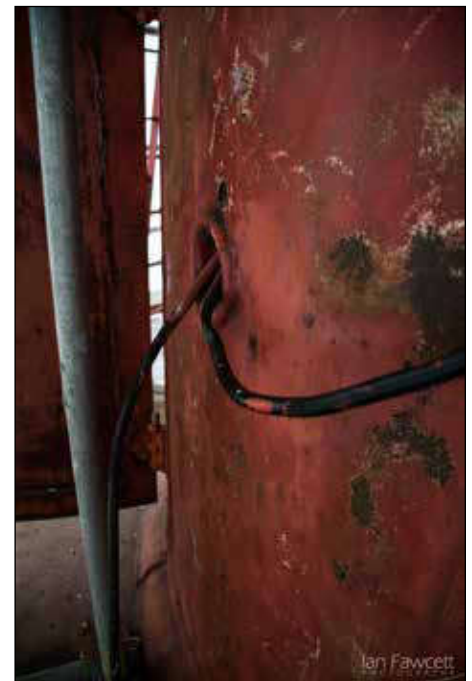
Images 81, 82 and 83: previous arrangement of cables in lantern room, going through vents to the exterior, and loose cables exiting vent on the outside

The main challenge was that the cables feeding the exterior equipment had been fed casually through the vents, rendering them non-functional. As the vents were being restored, an alternate route for these cables was necessary. An option was considered of routing the cables through a more-recently-added aluminum frame window, rather than cutting into the historic fabric of the lantern room itself, however, after consultation with an electrician, it was determined that this option would not be possible (to provide a secure exit) without further damage to the lantern room wall. Accordingly it was decided to re-route these cables through a small hole drilled adjacent to one of the vents to provide proper, sealed and permanent access to the exterior (the same as had been done previously for other cables). (See following photographs).

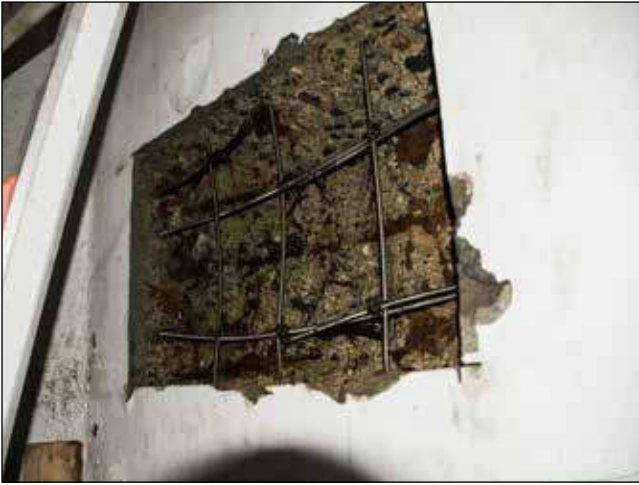
Images 86(top left) and 87 (centre left): show repair target areas chipped out with stainless steel reinforcing bar (grid) inserted

Among the first steps taken was an inch-by-inch examination of the entire interior of the tower walls, to identify every weak spot and mark it for repair. It was decided that repairs would be done by using hand-held equipment to chip away and deteriorated concrete. This was the safest and most “heritage-sensitive” approach, removing as much deteriorated material as necessary, but as little as possible. The exposed areas were then refilled with a pre-mixed, polymerized cement mortar compound (Planitop-X). In larger exposed, the mortar was reinforced with a re-bar grid. (See following photographs).

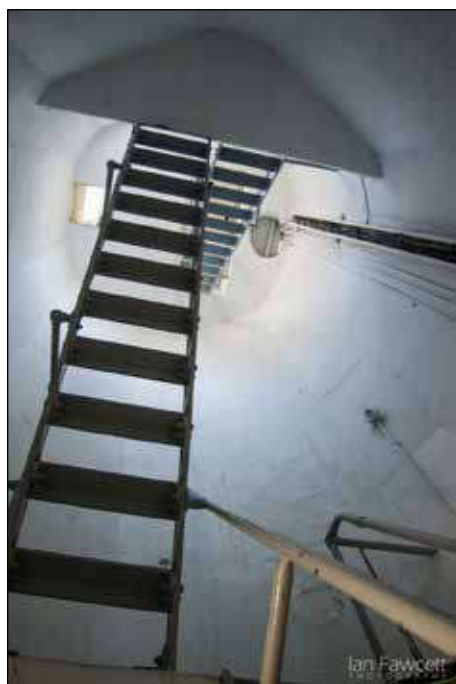
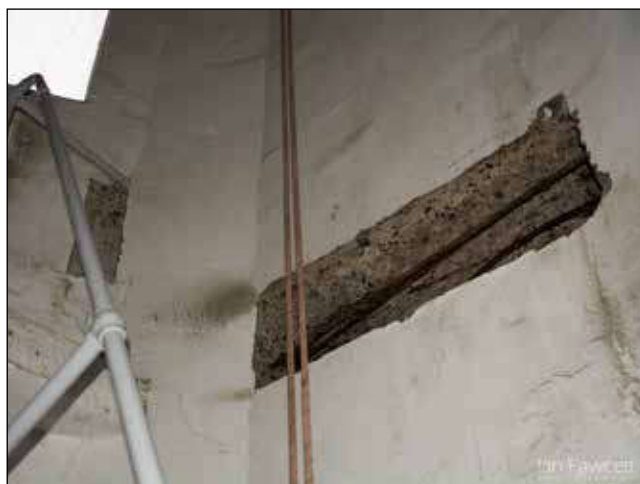
Images 92 and 93 (top row): showing stained and flaking condition of paint in tower interior

The same paint materials were used as in the lantern room, with white for the walls, and deck grey for the staircase and floor. Two coats were applied, a base coat/sealer and a top coat. (See following photographs).

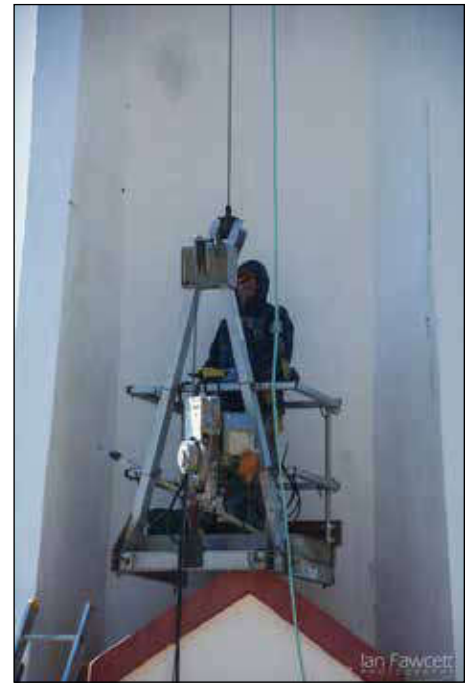
Image 102 (top left): pre-painting condition, showing staining at top, along buttresses and around base

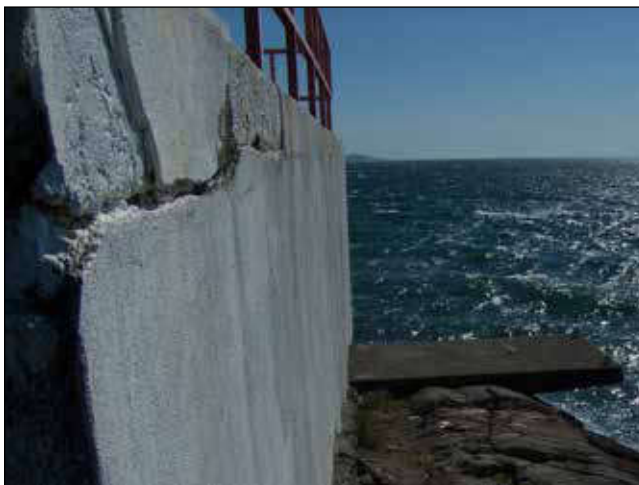
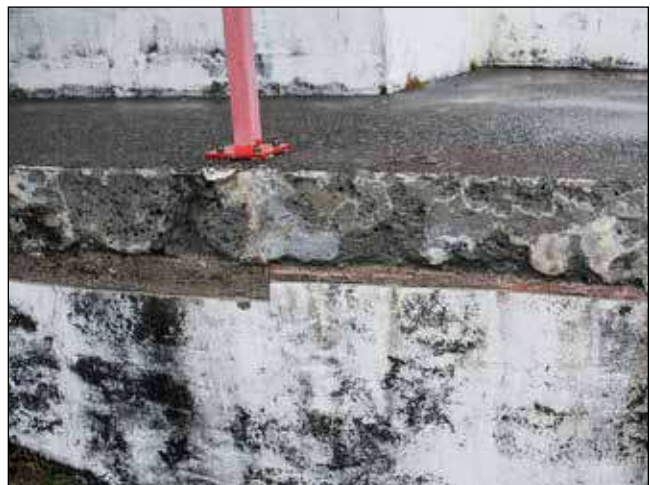
Images 108, 109 (previous page and 110 (top left): showing cracking and crumbling in concrete base and stairs of engine room

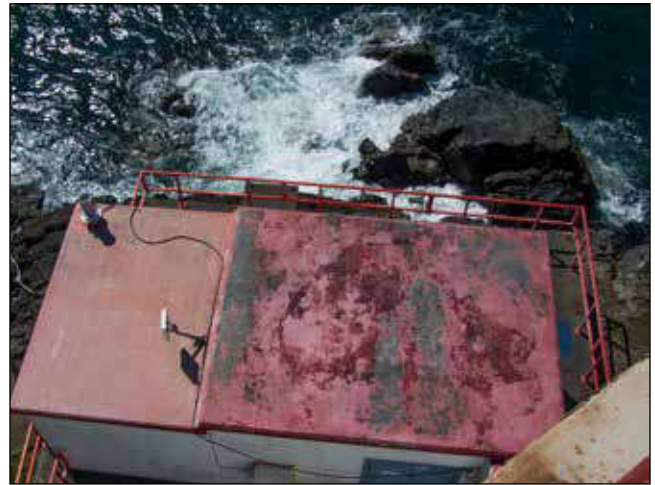
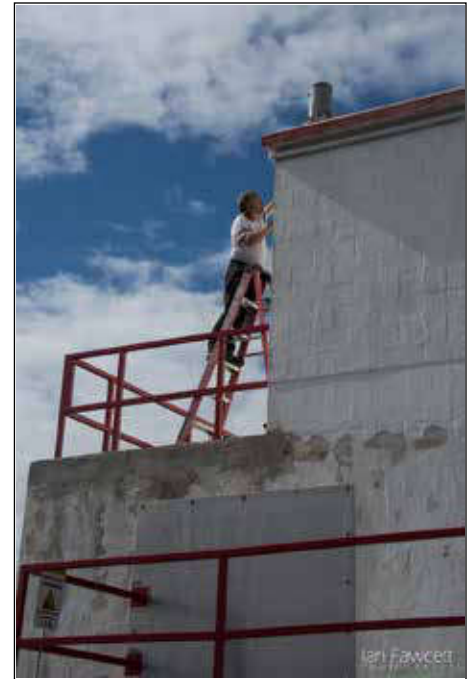
Note: since the painting was completed, a small water leak from the roof has been detected. The point of ingress is where a dish transmitter (installed by the Department of Fisheries and Oceans for it whale monitoring program) is attached to the roof. The point of attachment will be caulked until such time as the transmitter is removed (connection will be via the Society's communications cable), at which point the area will be sealed. (See following photographs).

Images 114, 115 (top row) and 116 (centre left): show paint condition on walls, roof and base

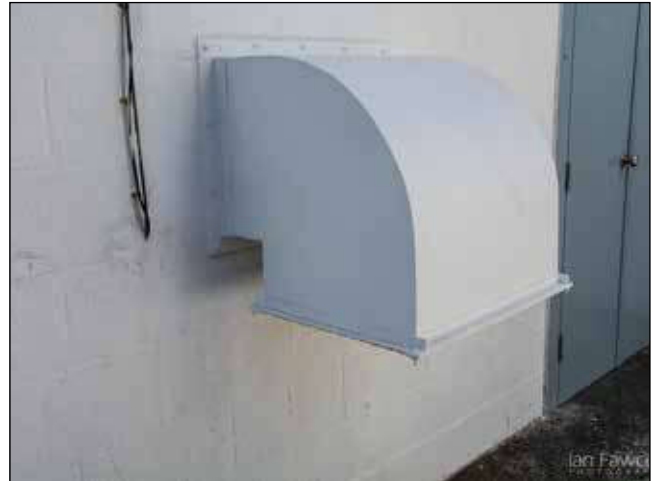
An air vent hood attached to the north wall of the engine room was seriously corroded, with parts of it completely eaten away. Also the metal brackets that attach it to the wall opening were seriously corroded, beyond repair. The vent hood was removed and taken to Foggy Mountain Forge, where a replica hood and mounting brackets were manufactured. The hood new hood was installed, and then painted. (See following photographs).

Images 120 (left): vent hood showing extensive corrosion damage

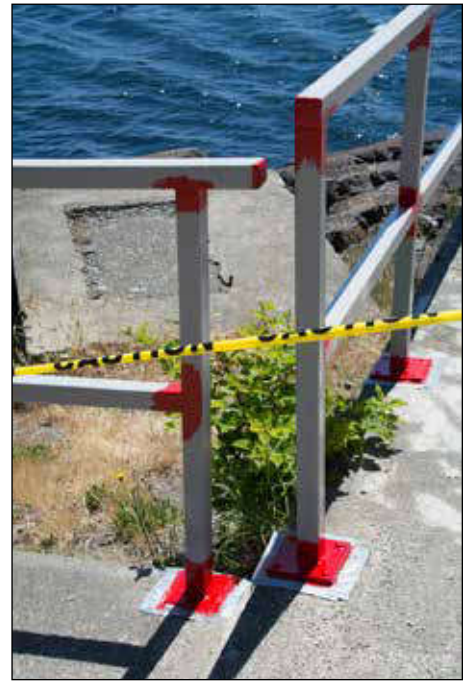
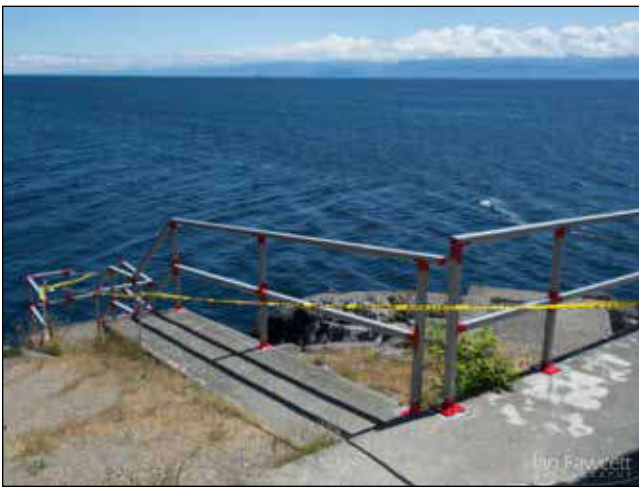
Images 131 and 132 (top left and centre): condition of remaining rails

It had been noted, through observation of on-site visitors, that it was quite common for people – especially children – to lean through the existing safety railings to gain a better view of the rocks/water below. This was also a concern expressed by the CRD building inspector during his visit. The vertical drop (especially on the south side of the engine room platform is significant (estimated at about 20 ft.) and is a severe hazard. Accordingly, it was decided to insert braided, stainless steel cables (3/8”) horizontally in the gaps of the railings to prevent people from leaning through. A design was developed, and the holes through which the cables would be strung were drilled (prior to painting). Unfortunately, the hardware fasteners (in-line stainless steel tensioners) required to install the cables as designed could not be found. As a result, this component of the work was put on hold until such time as the fasteners can be sourced. This component of the project was moved to the Capital Gaming Grant project, and work continues to find the appropriate materials. (See following photographs).

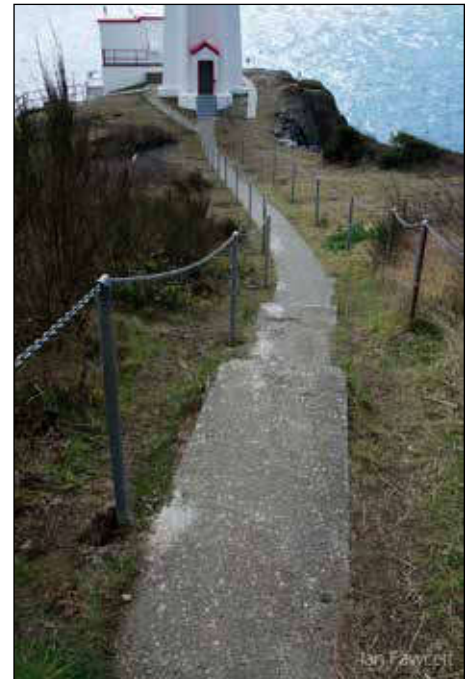
Image 137 (left): pathway and stanchions, in original location and without chain rails

In addition, four of the required stanchions had been lost over the years, and these were replaced with new stanchions of the same size and design. (See following photographs).

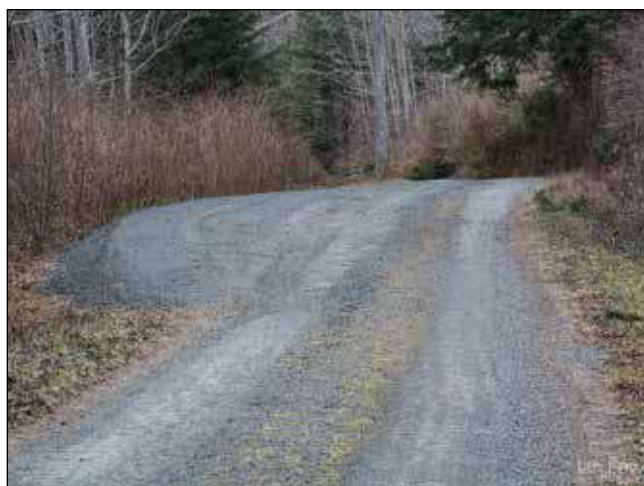
Image 144 (left): original road condition, with vehicle turnout (passing area) under development

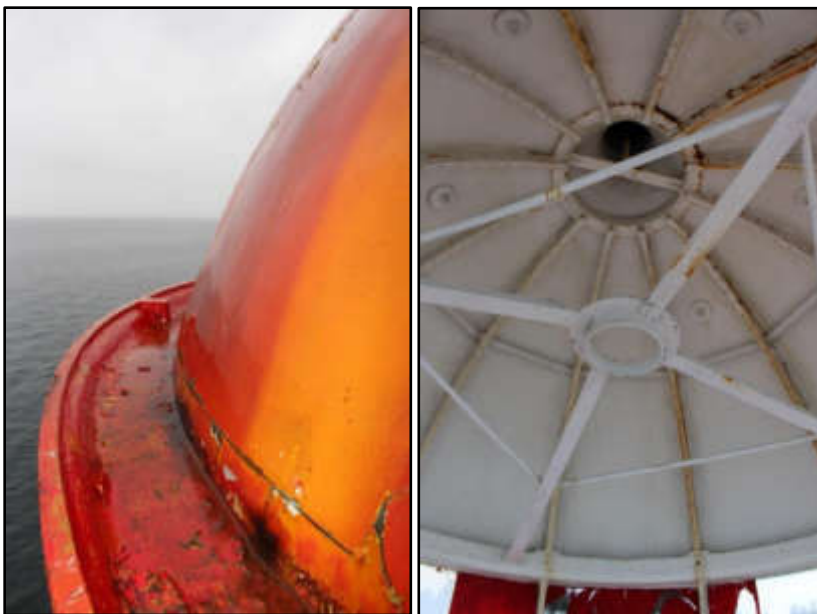
The roof appears to be in fair condition, protected with multiple layers of paint. The exterior coating fading away exposing a yellow underlayer (see *photograph 7*). The gutter appears to be in fair condition though corrosion is developing along the underside surface. On the interior, the structural ribs supporting the roof are corroding, likely due to the accumulation of condensation (see *photograph 8*).

Photographs 7 & 8 – Discoloured exterior paint and corroding interior roof structure
