SHERINGHAM POINT LIGHTHOUSE

RESTORATION
2015 - 2019

Final Report
&
Documentation

Sheringham Point Lighthouse
Preservation Society

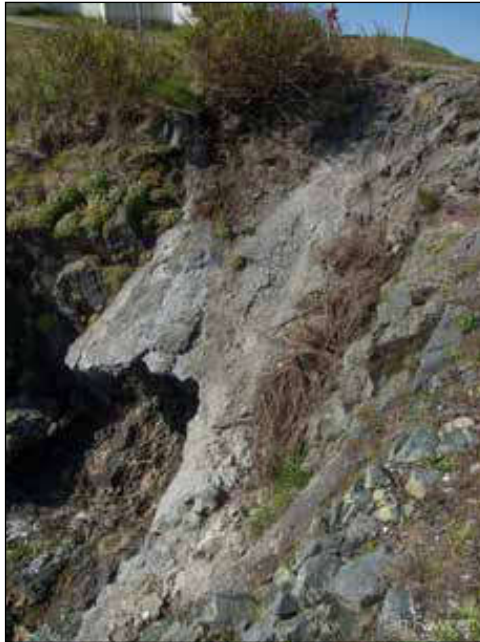
Image 3 (top left): erosion on the east side of the causeway

On the west side, a backhoe was used to place large boulders, individually in a stacked wall adjacent to the inside wall of the gulley. The stacked wall tilts slightly inward to ensure the greatest stability.

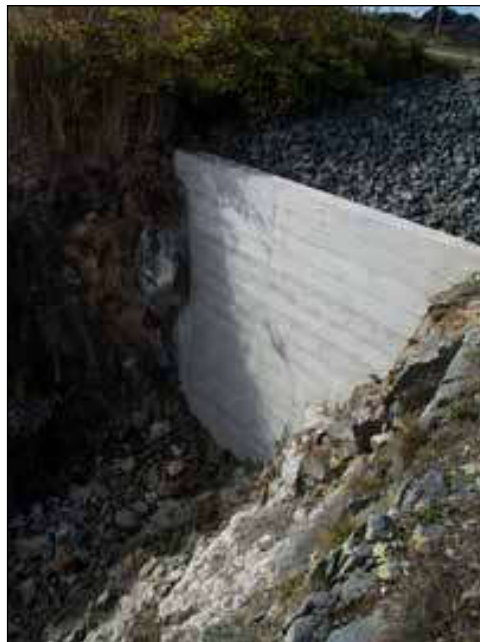
Image 6 (bottom left): reinforced retaining wall, with aggregate fill on east side of causeway

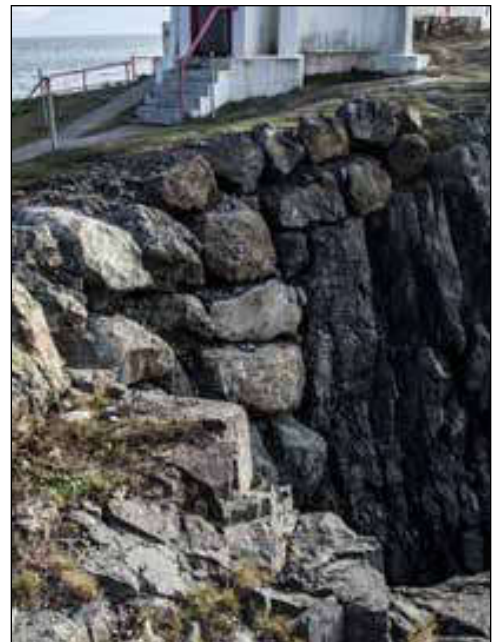
Image 7 (bottom right): stacked boulder wall on west side of causeway

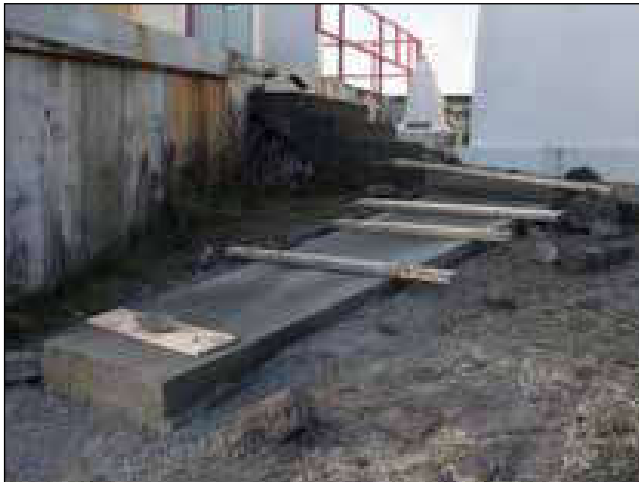
Image 8 & 9 (above): new pathway under construction & completed

Previously, there was no defined pathway connecting the existing concrete pathway that led around the east side of the tower to the concrete pathway along the eastern side of the engine room (and leading down the stairs to the lookout). This area was just bedrock, and was uneven. As it was one of the areas most heavily used by visitors, it was a serious tripping hazard. A decision was made to build a new concrete pathway to connect the two existing pathways. As Clarkston Construction was on site with a cement mixer (for the retaining wall), they were asked to also install the pathway. This now provides a safer walkway all around the heritage structures. (See following photographs).

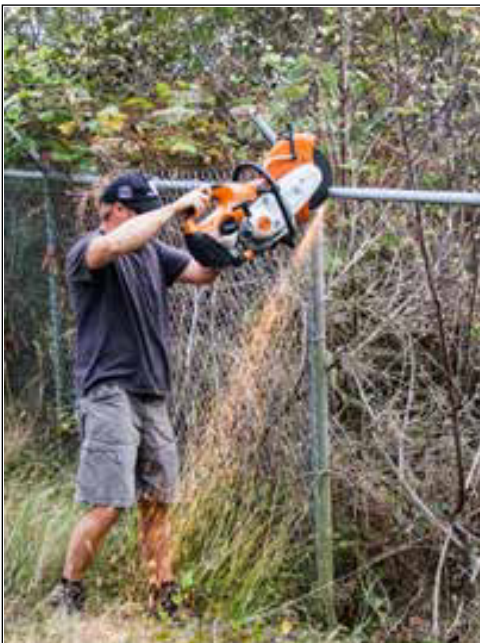
Image 10 (left): removal of fencing to permit access. Note: upon replacement the fence was re-designed so that this section can be removed easily to permit future access without requiring cutting.

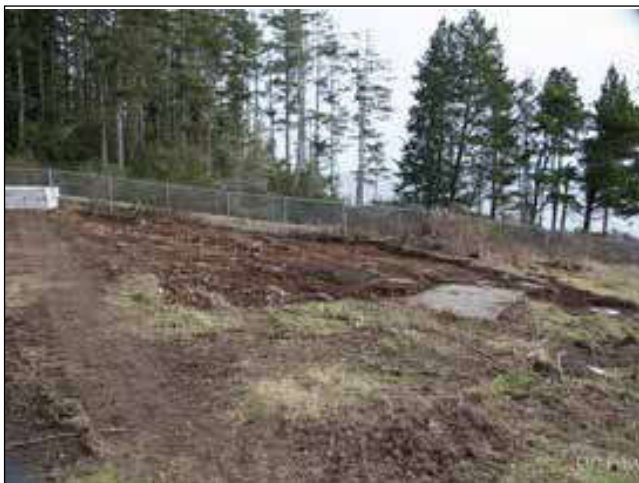
Image 12 (above left): cleared site for installation of solar array

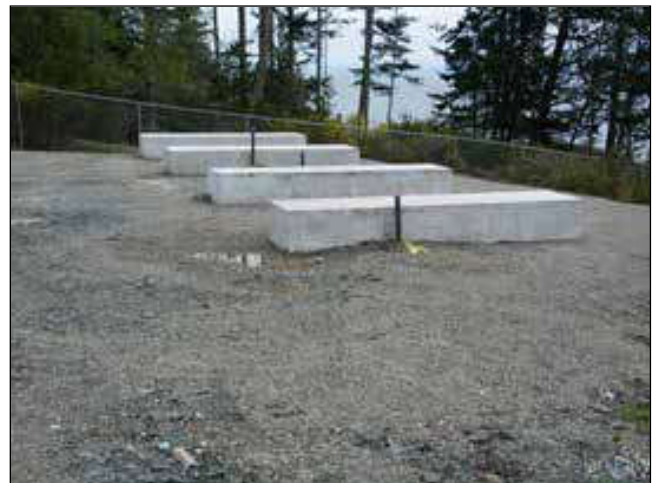
Image 13 (above right): array site filled, compacted and levelled with concrete ballasts installed

Once the site had been cleared, levelled and compacted, it was assessed by a geotechnical engineer (Ryzuk Engineering) to ensure that it was stable and would provide a secure base for the array. After engineering approval, four concrete ballasts were moved into place on the pad as the foundations for the array. The aluminum frame infrastructure was installed and attached to the base and the solar panels attached to the frame. Twenty-four 265-watt solar panels were installed, facing south and tilted at an angle of 30 degrees.

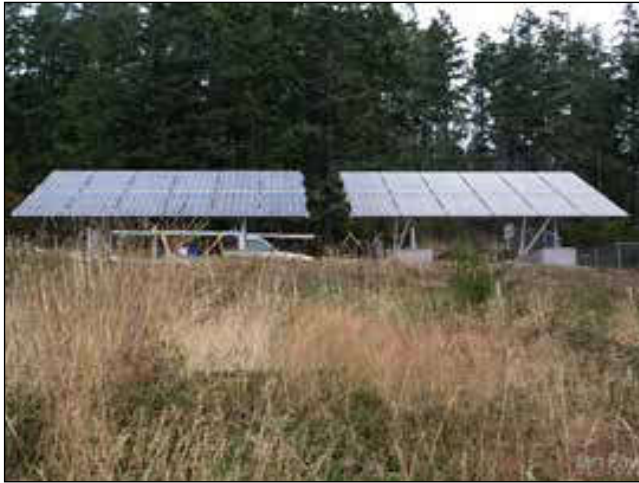
Image 14 (above left): 24 solar panels installed

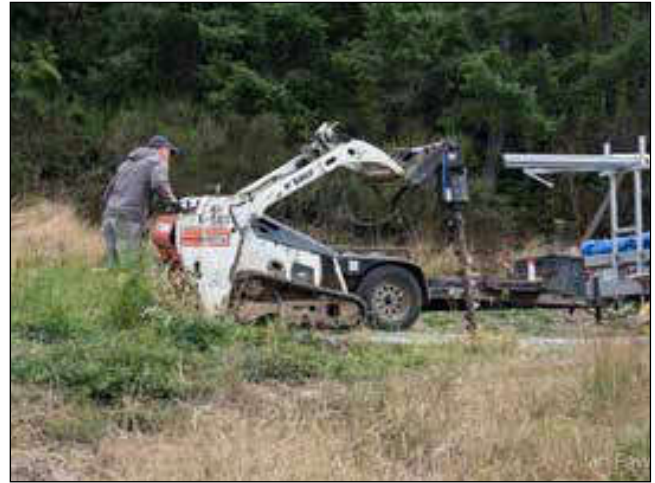
Image 15 (above right): digging post holes for installation of protective fencing

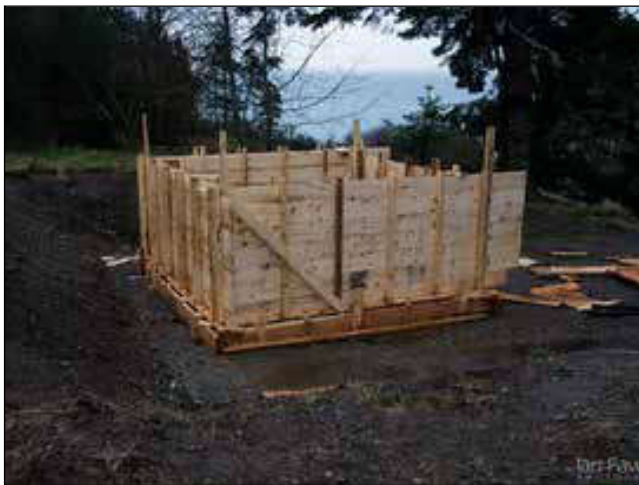
Image 17 (top left): excavation and foundation forms

In preparing the site for the building, an error was made in the excavation, which was deeper than originally anticipated. As a result, it was decided to place the shed on a foundation, rather than a concrete pad, in order to bring it back up to grade. The building itself was a frame construction, approximately 10' x 10' in diameter, with a peaked roof. It was vented at each gable end and the entrance door located in the west wall. Hardy plank siding was used to finish the exterior and a sheet metal roof installed. Final painting of the shed (interior and exterior) was done by Society volunteers. (See following photographs).

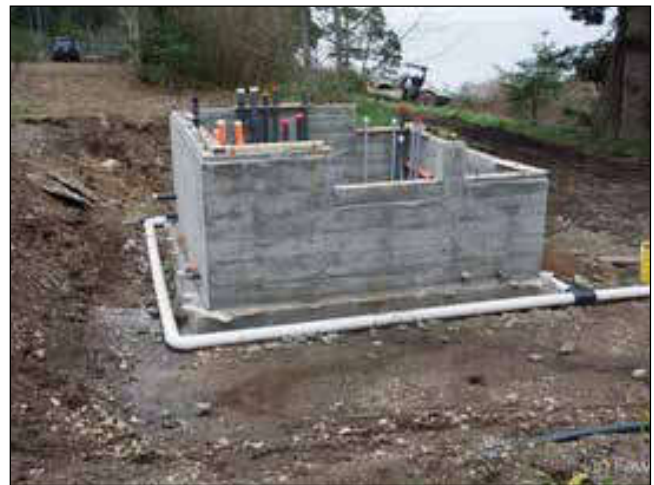
Image 18 (top right): foundation completed and conduit installed

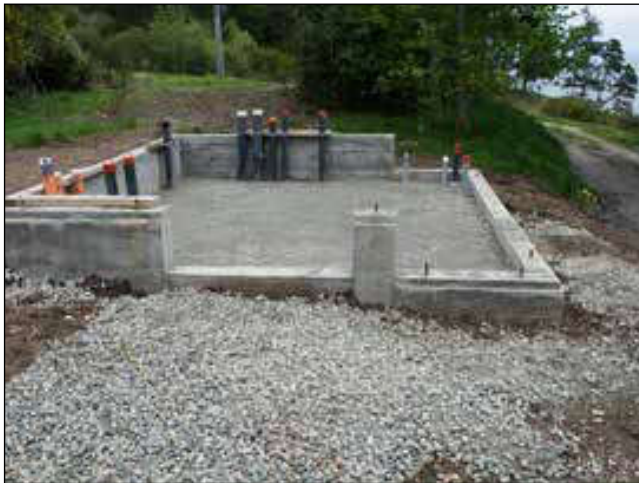
Image 19 (bottom left): re-filled and concrete floor installed

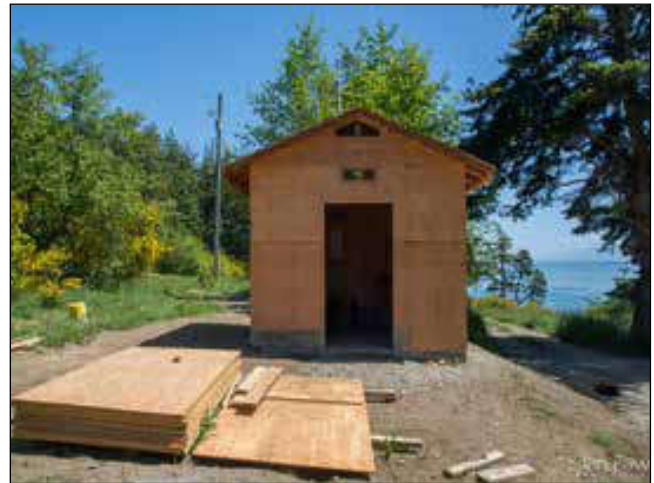
Image 20 (bottom right): framing and sheathing completed

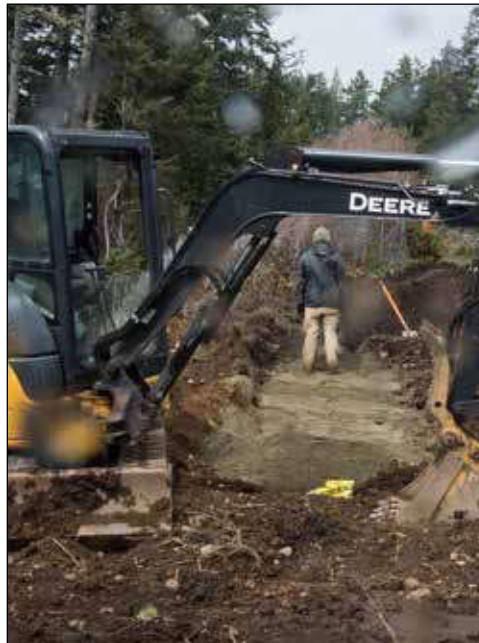
Image 25 (centre): digging the trench along the causeway

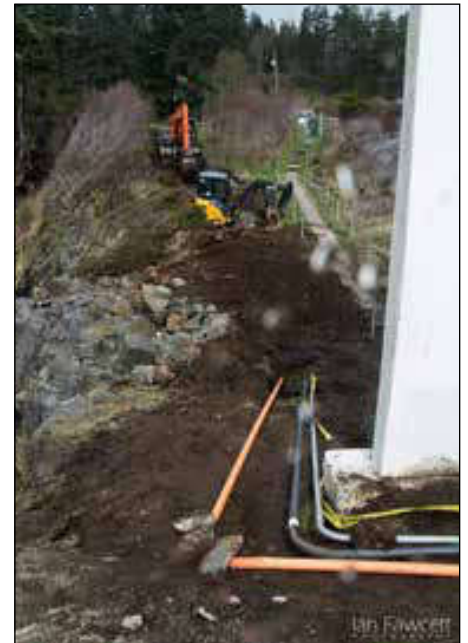
Image 26 (right): power and communications conduits extending above the bedrock at base of tower

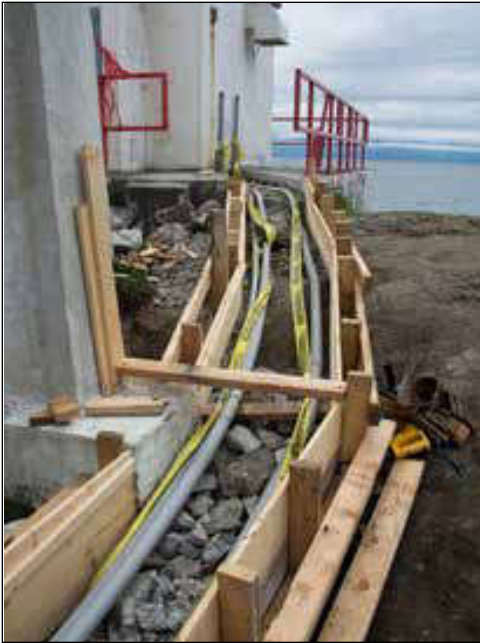
Image 27 (top left): forms for concrete conduit cover

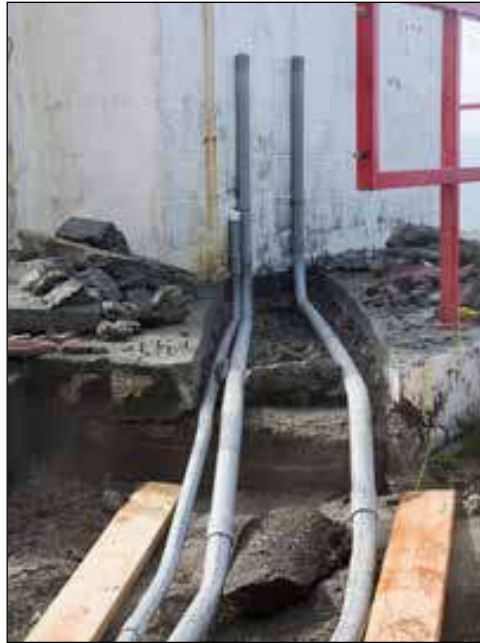
Image 28 (top right): incursion into engine room base

Upon reaching the structures, we had to find a new path inside the buildings to connect to the panel. The previous ingress (into the engine room) was no longer useable (due to inaccessibility and corrosion). We had the option of either drilling through the wall of the tower, or cutting a path across the concrete base of the engine room. Both options were not good, and would negatively affect the historic fabric of the structures. It was decided that the tower structure was of the greatest historical value and should not be compromised. Therefore a trench was cut into the concrete base of the engine room. Care was taken to ensure that this cutting was as minimal as possible. Once the conduits were laid, it was concreted over. New conduit was placed on the exterior of the west wall of the engine room, replacing the existing corroded conduit, and entered the engine room through two new holes drilled through the concrete block wall. The corroded conduit was removed and the entrance hole filled. (See following photographs).

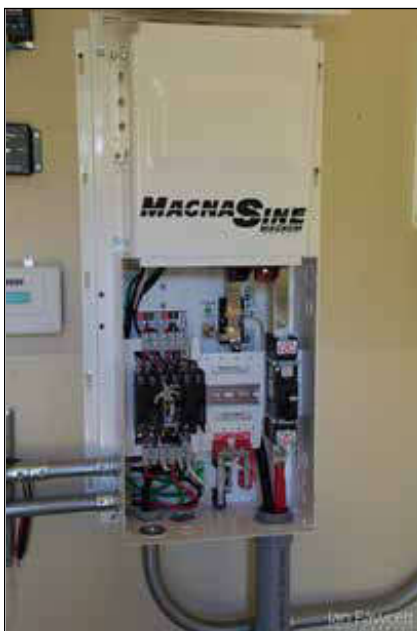
Image 31 (top left): electrical panel and solar power equipment in shed

A new 200 amp main electrical panel, an essential loads panel, disconnects and pull boxes were installed in the electrical shed, along with lighting and a baseboard heater. A power consumption meter was installed on the outside of the electrical shed, as well as an 8-foot aluminum pole to elevate the power and communications cable connections to the main power pole beyond reach.

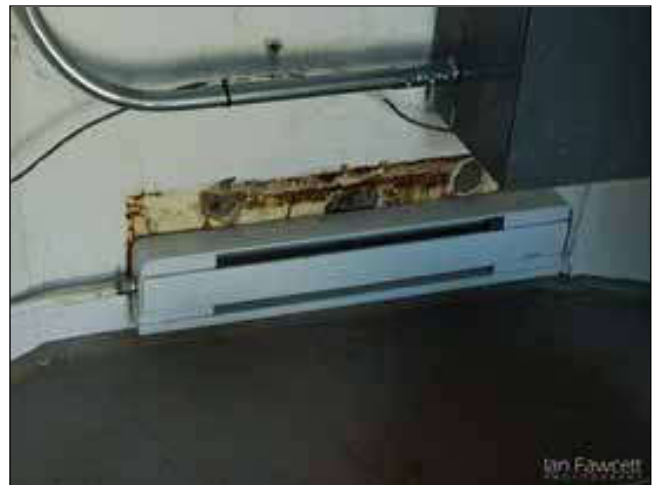
Image 35 (top right): Replacement baseboard heater in tower

The basic electrical fixtures in both the engine room and tower were corroded beyond usability and were replaced. This included overhead lighting (fluorescent) and baseboard heaters in the engine room, and wall -lights and baseboard heaters in the tower. Efforts to find exact replicas of these fixtures in reasonable working order were unsuccessful, so near-approximations were used. In addition protective steel cages were installed over the bare lightbulbs in the tower to ensure user safety. (See following photographs).

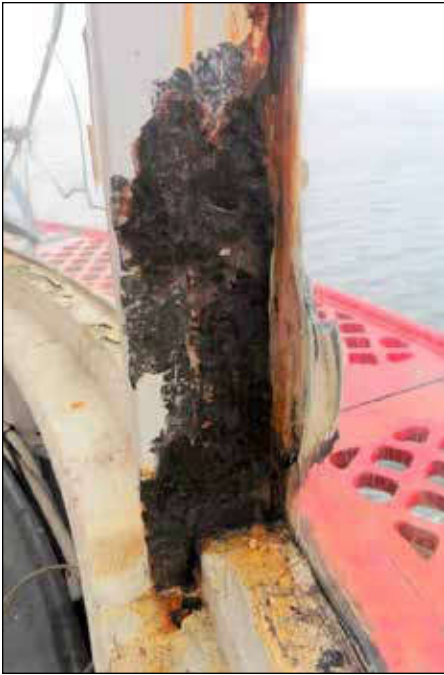
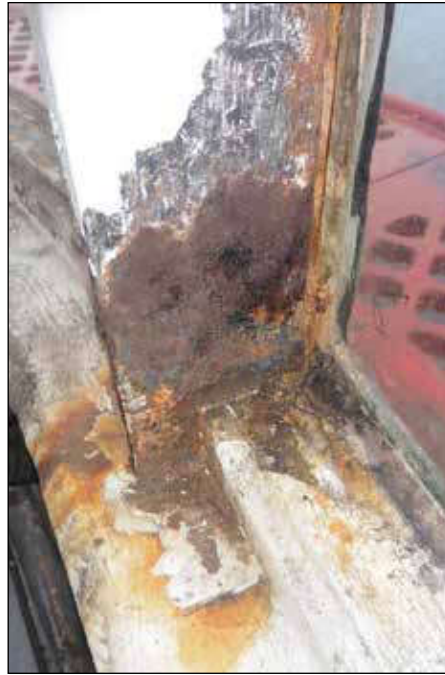
The removed mullion was taken to Smith Bros. Foundry and Machine Works, where it was cleaned to permit examination by John Dam. Fortunately the corrosion was found to be limited to the exterior of the mullion, and its structural integrity was sound. This meant that the remaining mullions (which were not as badly corroded as the test one) could be left in place, and just surface cleaned. This also meant that the strategy for restoration and, in particular, the window replacement, would be significantly simpler (and cheaper) in that no shoring would be required and all windows could be replaced at once. The removed mullion was later re-installed by welding it back together on site, with a small extension (about ½ inch) added to replace the material that had been cut away. (See following photographs).

Image 39, 40 and 41 (top row): corrosion on lantern room mullions, prior to treatment

John Dam & Associates were consulted as to how to extricate one of the mullions without damaging the surrounding structure, as well as how to re-install the original (or replacement) mullion without having to cut into the surround structure. As it was secured in place, and could not be removed without cutting either the mullion itself or either the wall or roof structure to which it was attached, it was decided to cut the mullion on site in order to remove it. This required prior removal of six window panes (one column on either side of the mullion) and installation of two screw jacks to support the roof. The gap in the windows was also boarded up.

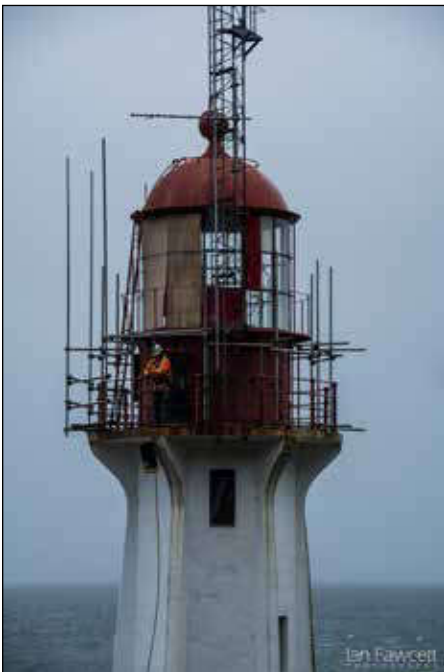
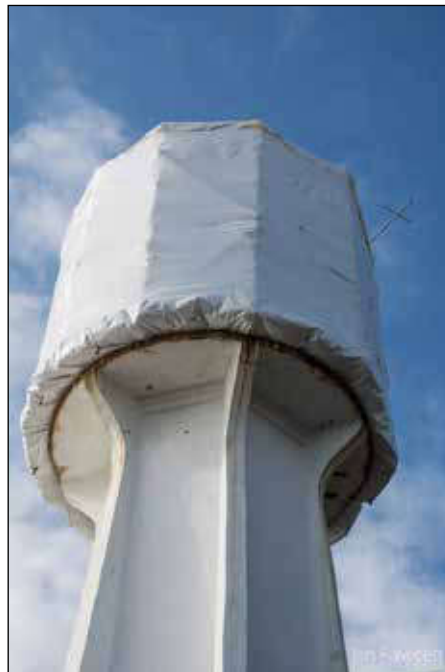
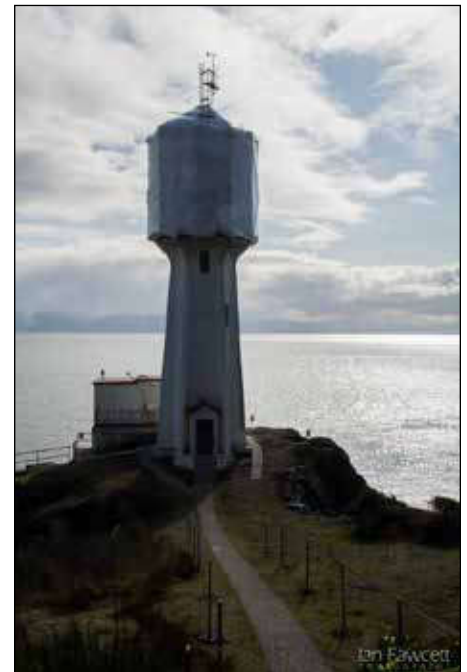
The presence of the scaffolding and, in particular, the sheathing caused issues for the navigational aid and weather monitoring equipment on site. The Canadian Coast Guard attended the site and relocated the beacon, mounted on extension bars, to the outside of the housing. Following removal of the hoarding, the Coast Guard returned and re-mounted the beacon on its bracket attached to the exterior of the lantern room.

Image 44, 45 and 46: scaffolding (in process) and completed sheathing erected around lantern room

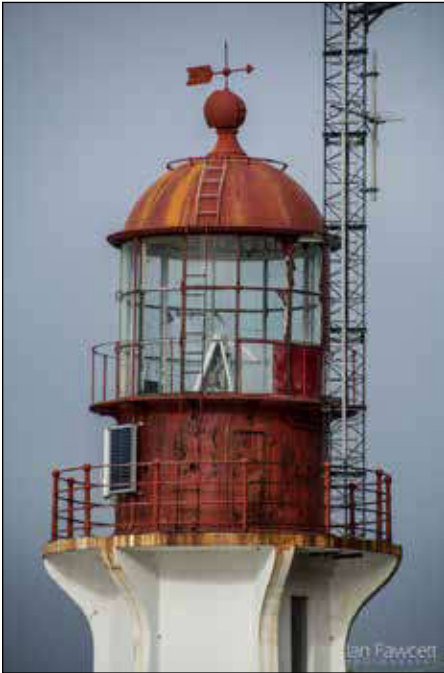
Image 47 (top left): lantern room exterior showing extent of corrosion on walls and roof

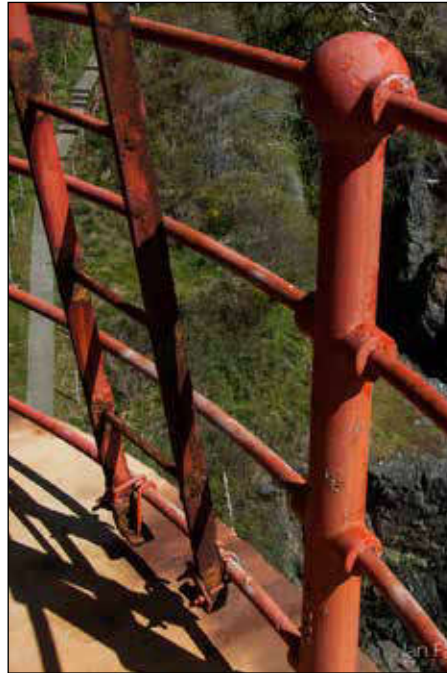
Image 48 (top centre): rails and ladder showing corrosion - extensive in some localized spots (e.g. bottom of ladder)

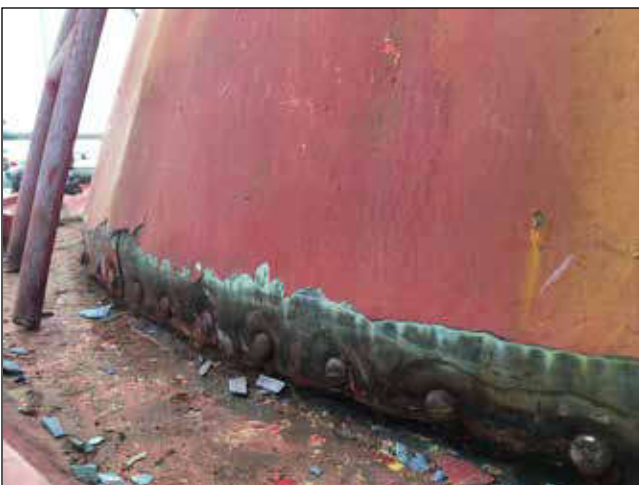
Image 52 (top left): dome exterior, in progress, with surface corrosion removed and prepped for painting - showing it is made of copper

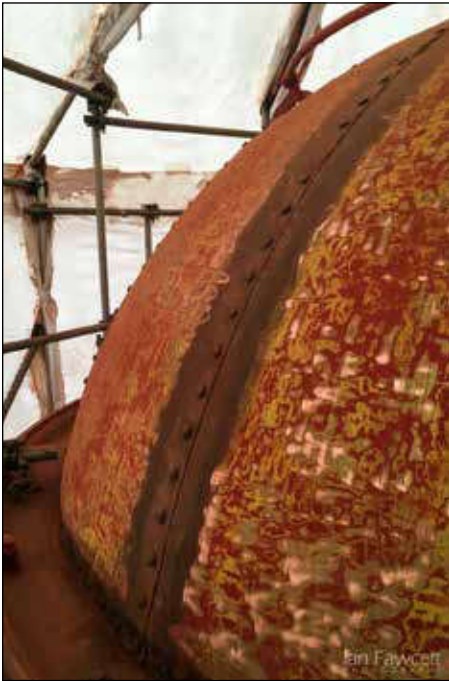
The lower walls, catwalk and rails required moderate grinding to remove the corrosion and prepare them for painting. The dome, however, required a heavier grinding and was taken right down, in some sections, to bare metal. In so doing, it was discovered that the dome was constructed of copper, not cast steel as had been previously thought (and as the remainder of the lantern room walls and structures are). Also the downspout water drains from the roof were also found to be copper.

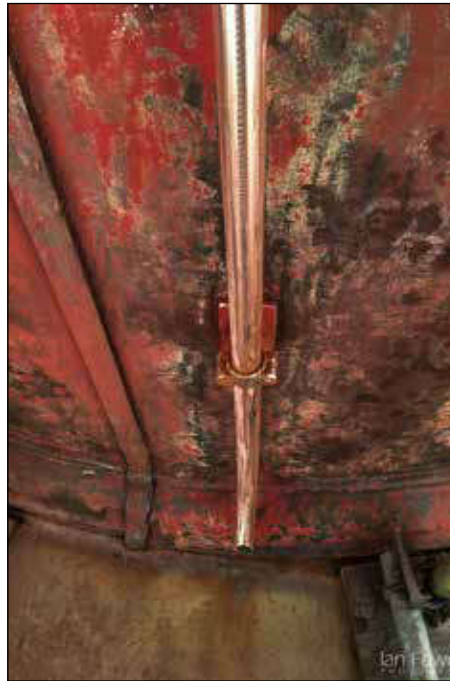
Image 53 (top centre): downspout cleaned and prepped - showing it is made of copper

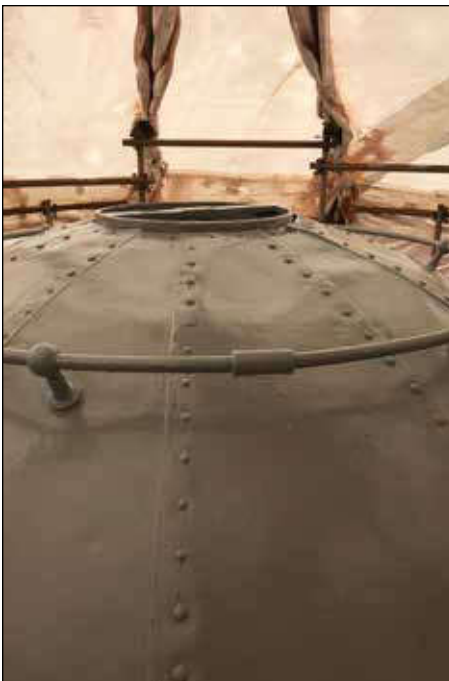
Image 55 (bottom left): dome, in progress, with base and intermediate coats, prior to red top coats. Weather vane and housing removed.

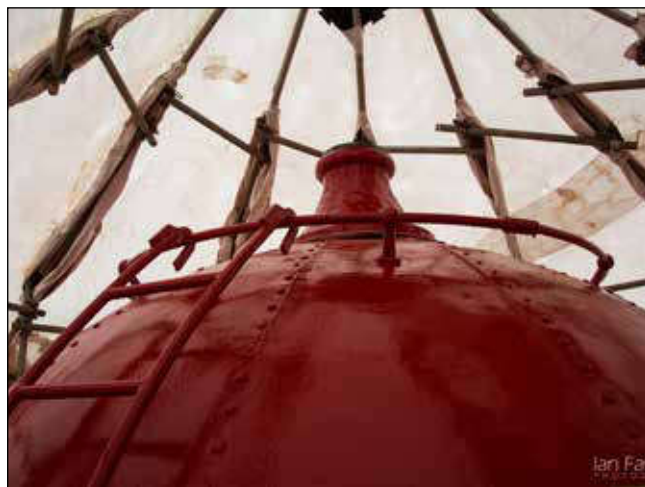
Image 56 (bottom right): dome, in progress, with red top coat freshly added. Weather vane housing replaced.

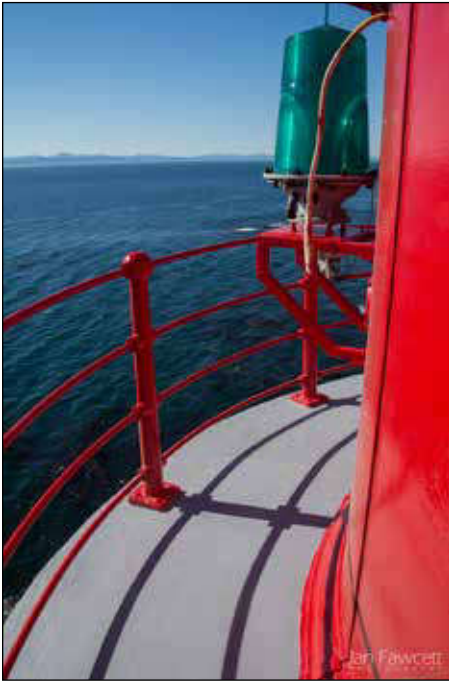
Image 57 (left): exterior lantern room wall, platform and rails, completed

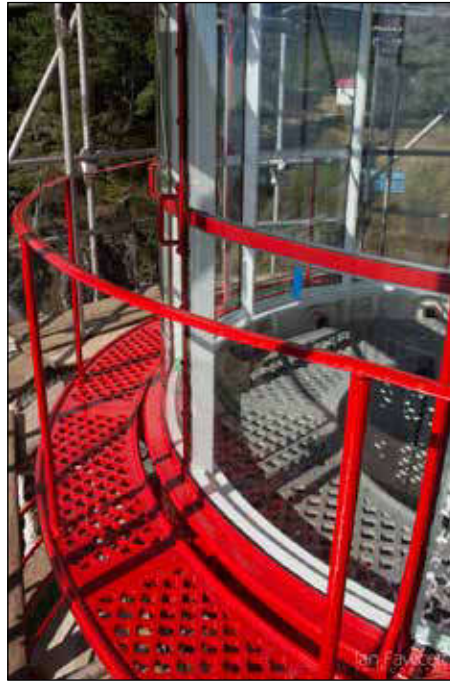
Image 58 (centre): lantern room catwalk and window bands, completed

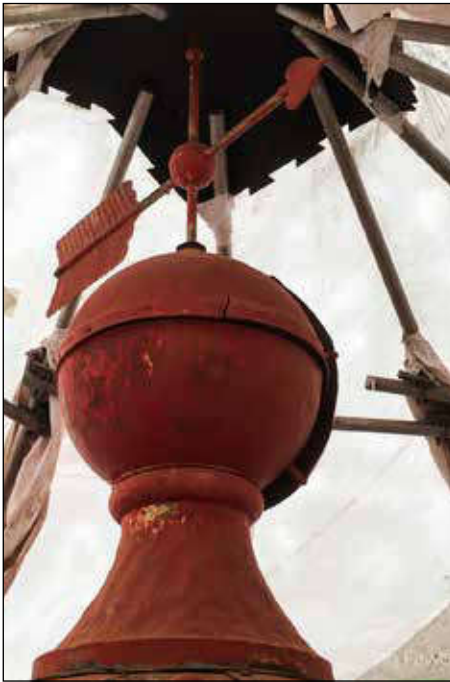
As we were able to access the top of the dome, we were able to assess the condition of the weather vane at the peak. It was severely corroded, to the point that it no longer was able to rotate or serve any function as a weather vane. The outer panels were cracked and deteriorating, and it was suspected that this was another point of water ingress, causing leakage into the interior of the lantern room.

Image 60 (top left):
weather vane showing
corrosion and damage,

- Leave it in place, clean out as much of the corrosion as possible and reseal and repaint it. This would mean it would be permanently frozen in place.
- Remove it from the roof, and restore it in a foundry, cleaning out the corrosion and replacing the deteriorated components. This would allow the weather vane to rotate again, and function as it should.

The second option was chosen. Unfortunately, the corrosion was so extensive at its base that it could not be removed without cutting it out, meaning that a new mounting collar would need to be fabricated.

The weather vane was cut from the tower, the external panels removed and taken to Foggy Mountain Forge for restoration and refabrication. Once cleaned, restored and repainted, it was reassembled. In its complete form, it was too large to be taken back to the top of the tower through the internal hatches, so it had to be raised with a winch up the outside of the tower, once the sheathing had been removed, but prior to the scaffolding being removed. It was reconnected with the new mounting collar, and now functions properly as a weather vane. (See following photographs).

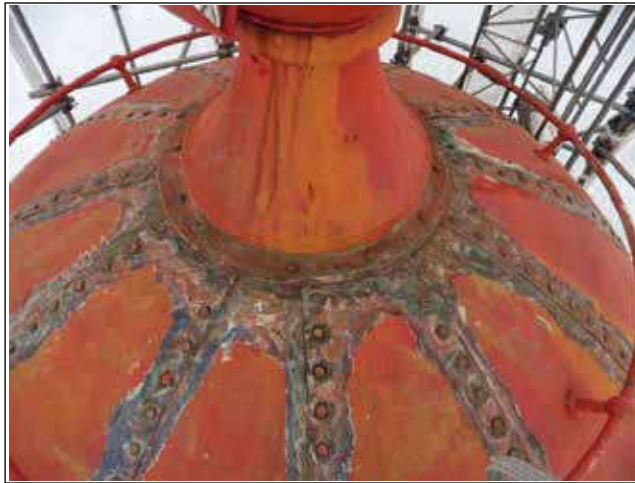
Image 61 (top right):
weather vane mount,
showing corroded
mounting ring

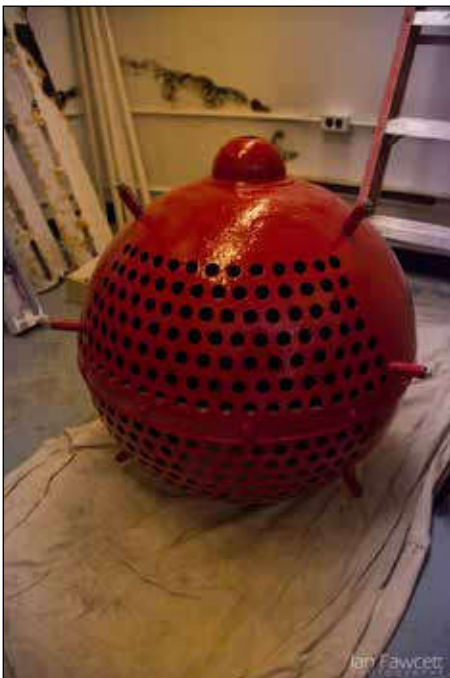
Image 62 (bottom left): weather vane cleaned and restored

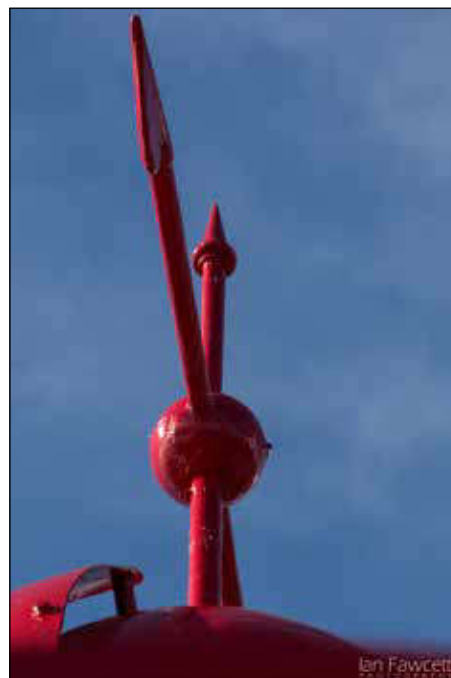
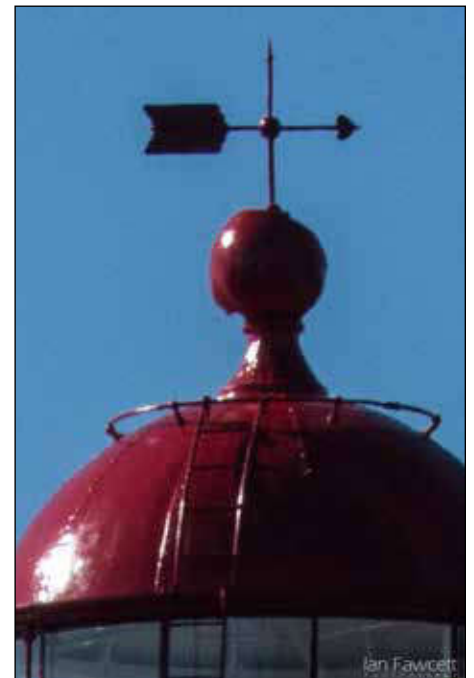
Image 63 and 64 (bottom centre and right): weather vane restored and reassembled atop lantern room

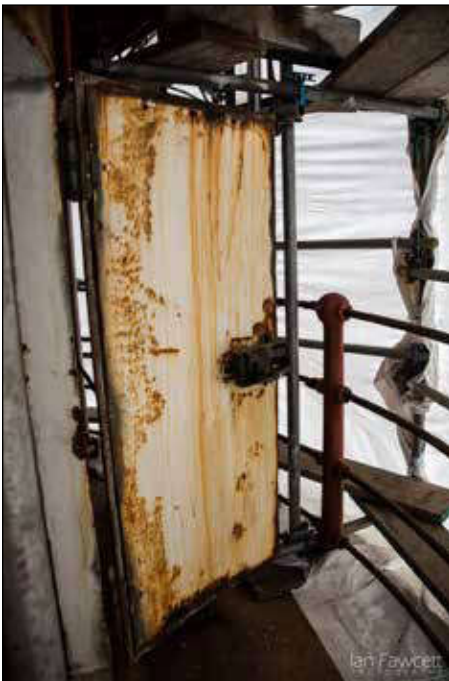
The exterior door leading from the lantern room to the exterior walkway was severely corroded, on both the interior and exterior sides. Blacksmith Marty Gilbertson (Foggy Mountain Forge) was consulted about how best it could be restored and it was recommended that the interior cast steel panel be removed and replaced, as it was too corroded to be repaired. It was felt that the exterior could be cleaned and restored.

Image 65 (left): lantern room door interior, showing corrosion and beginning of separation of top panel from the rest of the door

The door was removed from its hinges and taken to Foggy Mountain Forge, where the work was completed (except the painting). The restored door was rehung in the lantern room, but it was found not to close properly, due to the rigidity of the new plate that had been attached. This required that it be removed again, returned to the forge where it could be slightly bent, and then rehung. It now fit relatively well, and it was decided to install some weather stripping around the edges to provide a better seal. The door was then painted along with the rest of the lantern room. (See following photographs).

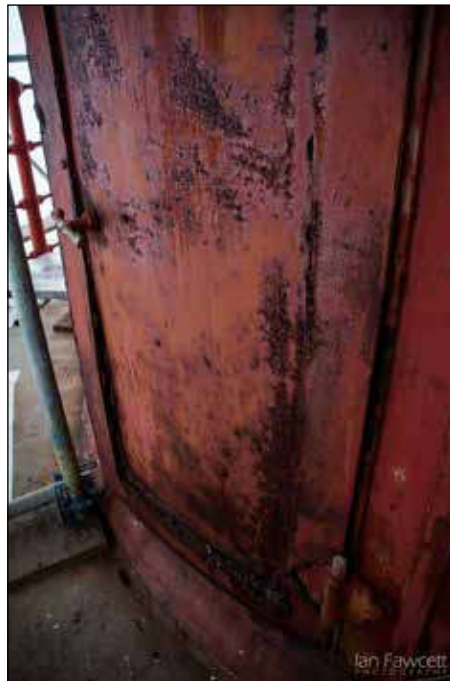
Image 66 (centre): lantern room door exterior, showing extensive corrosion

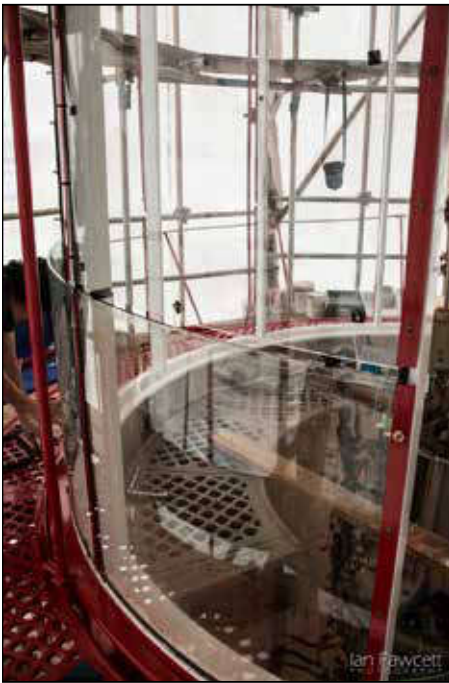
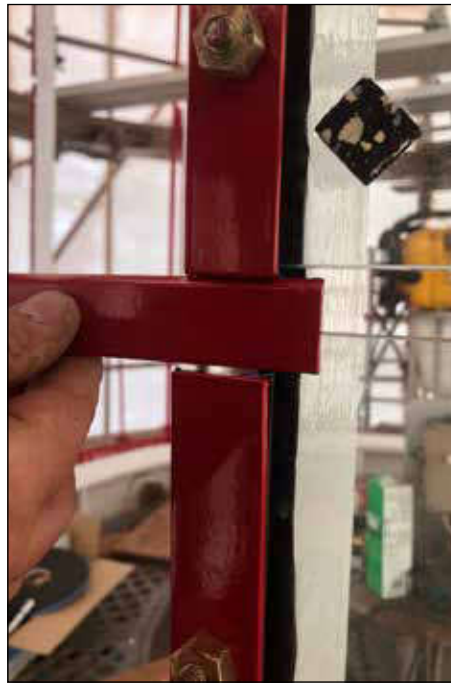
Image 72 and 73 (bottom row): replacement lantern room windows installed, with replacement, wider, mounting straps

It was decided to replace all of the windows. Twelve new panes were already on hand (as surplus) when the lighthouse was transferred to the society. One of these windows was taken to Gilchrist Glass Bending in Mill Bay as a pattern, and 24 new windows were manufactured from that pattern.

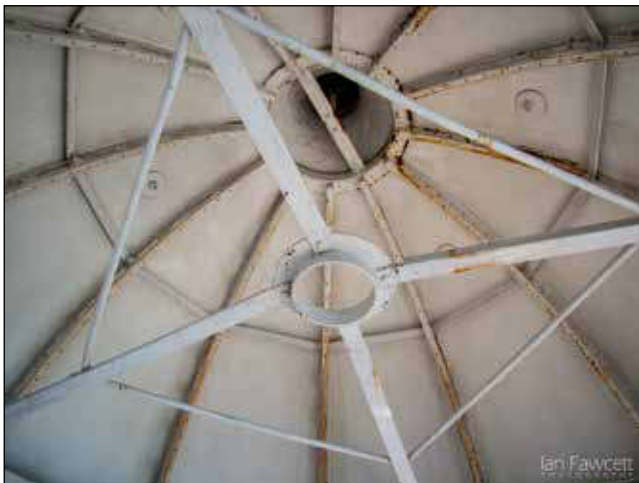
The interior walls, floor, catwalk, dome roof and structural beams were in relatively good shape, although they were stained in some areas (especially the roof) by water leakage. It was decided that the existing paint did not need to be removed, but could be simply ground down for painting preparation. Applications of paint were made as required (two or three coats in some critical areas – primer/sealer and topcoat). Colours were as indicated above (white walls, roof, beams and mullions, deck grey catwalk and floor).

Image 74 and 75 (top row): original condition of lantern room interior, showing some corrosion

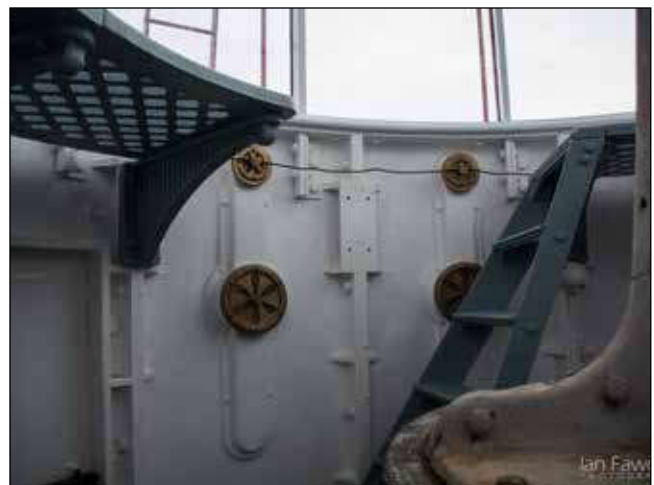
Image 76 and 77 (bottom row): lantern room interior after painting

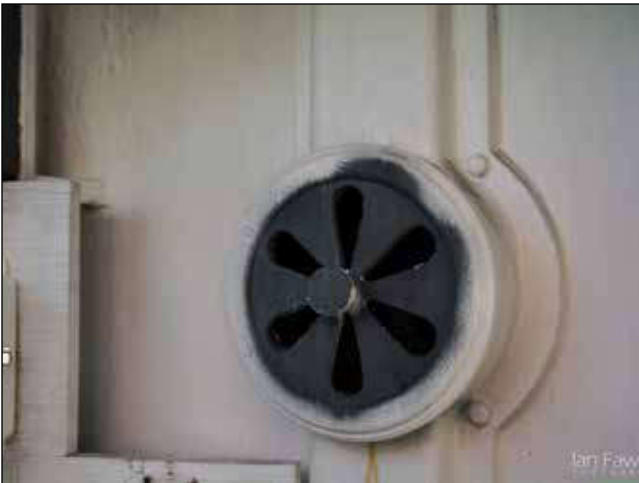
There are twenty small round vents located in the lower walls of the lantern room. They open and close by means of a central, hand-turned screw handle. All of these vents had several layers of paint, some had signs of corrosion, and all were non-functional (i.e. they could not be opened or closed as they were “painted shut”). It was decided to remove the vents, to be taken to the foundry (Smith Bros.) where they could be sandblasted to remove the existing paint and corrosion. Upon completion, it was discovered that these vents were made of brass, which was not previously known. Also, it was determined that many of the central screw-handles were no longer functional, nor were many of the mounting screws. Accordingly, replica parts were fabricated at the foundry.

Image 78 (top left) and 75 (previous page): show vents in original condition

Rather than repaint the (now) cleaned and functional vents, it was decided to leave them as bare brass, and reinstall them in that condition, both to improve their functionality and to show them more clearly in the lantern room. (See following photographs).

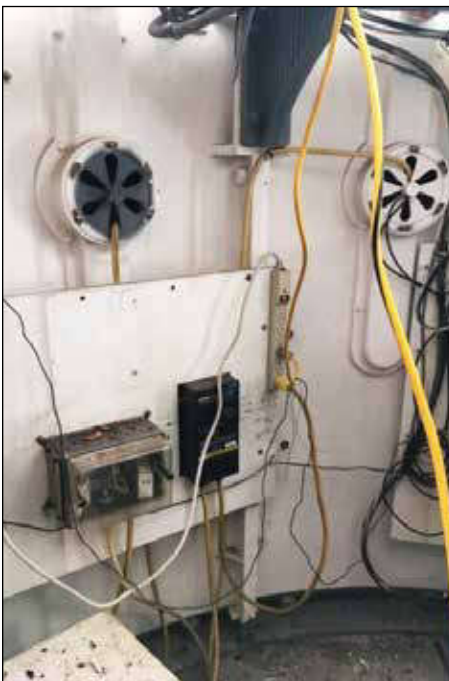
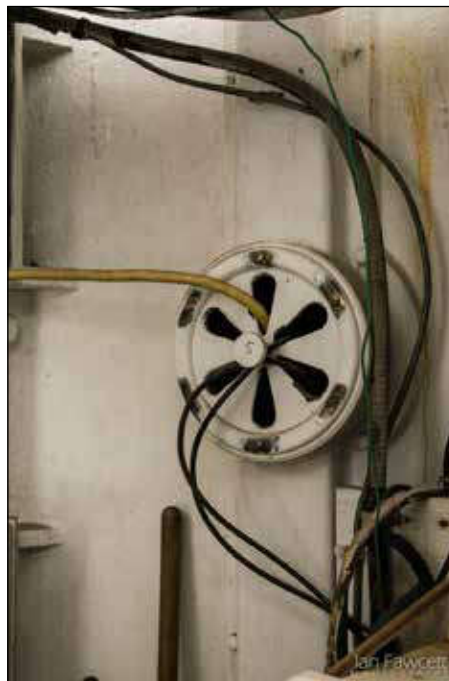
The main challenge was that the cables feeding the exterior equipment had been fed casually through the vents, rendering them non-functional. As the vents were being restored, an alternate route for these cables was necessary. An option was considered of routing the cables through a more-recently-added aluminum frame window, rather than cutting into the historic fabric of the lantern room itself, however, after consultation with an electrician, it was determined that this option would not be possible (to provide a secure exit) without further damage to the lantern room wall. Accordingly it was decided to re-route these cables through a small hole drilled adjacent to one of the vents to provide proper, sealed and permanent access to the exterior (the same as had been done previously for other cables). (See following photographs).

Images 81, 82 and 83: previous arrangement of cables in lantern room, going through vents to the exterior, and loose cables exiting vent on the outside

The solar panels were removed, and the beacon and weather station were connected to the site's power supply (the batteries were retained as backup). Extraneous cables were removed, and the remaining cables were replaced, relocated and restrung in an orderly fashion, as necessary, to enable easier movement within and around the lantern room.

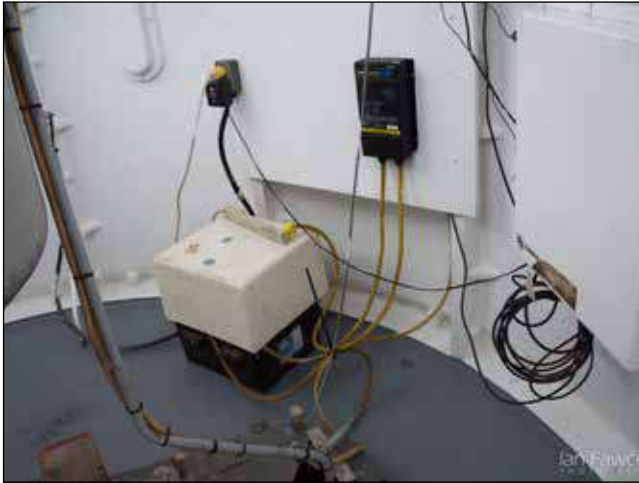
Image 84(left): showing cleanup of cables in lantern room

Image 85 (right): cables re-routed through new holes/couplings in lantern room wall adjacent to vent

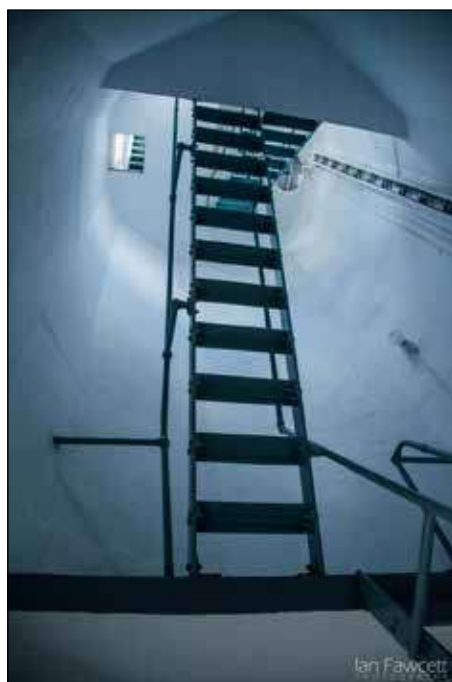
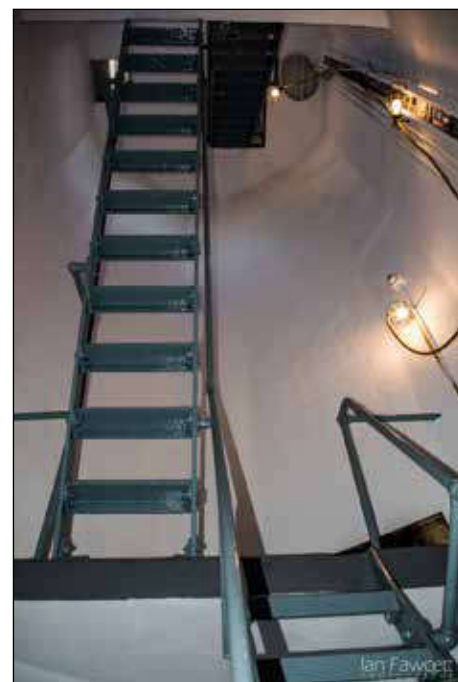
Images 94 and 95 (bottom row): tower interior following patching and repainting

The same paint materials were used as in the lantern room, with white for the walls, and deck grey for the staircase and floor. Two coats were applied, a base coat/sealer and a top coat. (See following photographs).

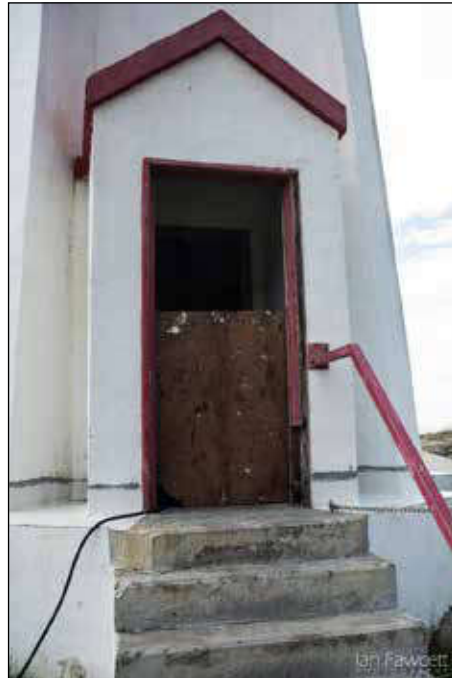
The wooden door jamb surrounding the exterior opening of the portico at the base of the tower had partially rotted (mostly on the west side), due to the effects of weather over the years. The rotted wood was cut out and replaced with a new wood of the same dimensions, then painted along with the remainder of the exterior of the tower. (See following photographs).

Images 96 and 97: showing rotting door jamb (right side of door), and restored door jamb after painting

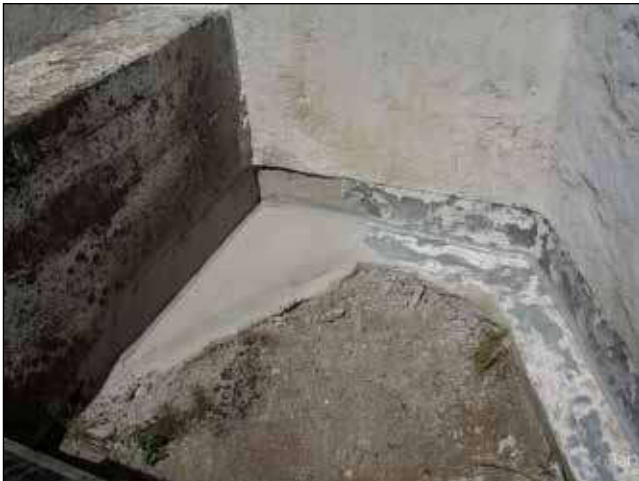
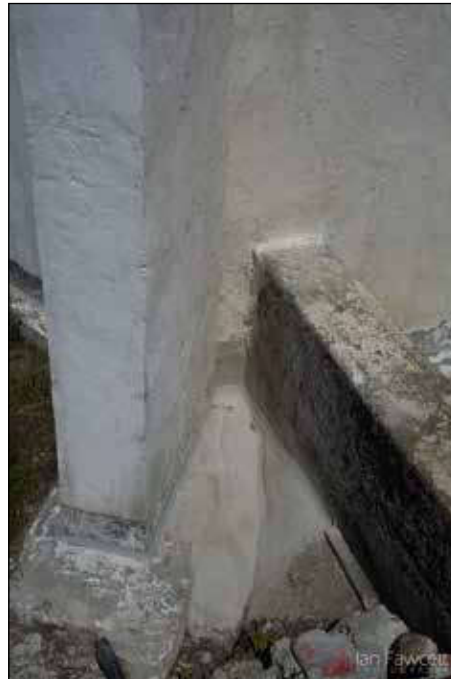
For some time, water had been pooling in the base of the tower following rain. It was believed initially that this was a result of the leaking in the lantern room, as water was periodically seen on the interior walls (which were also stained from the leaking). However, following the restoration of the lantern room, with no further evidence of leaking at that location, water was still found to be pooling at the base of the tower. This caused us to investigate further, and it was determined that due to the topography of the bedrock immediately to the south (water-side) of the tower, rainwater was collecting in the spaces between the buttresses on that side of the tower, and seeping through the concrete base into the tower.

Images 98 and 99 (top row): excavation to address leakage issue - compound patches are points of water ingress

As part of the landscaping work to be completed in the coming months, the disturbed area will be regraded to the extent possible, and refilled with gravel to improve drainage and help reduce water retention. It is likely, however, that due to the bedrock topography (which slopes toward the tower base) that this may be an ongoing issue, and should be monitored regularly.

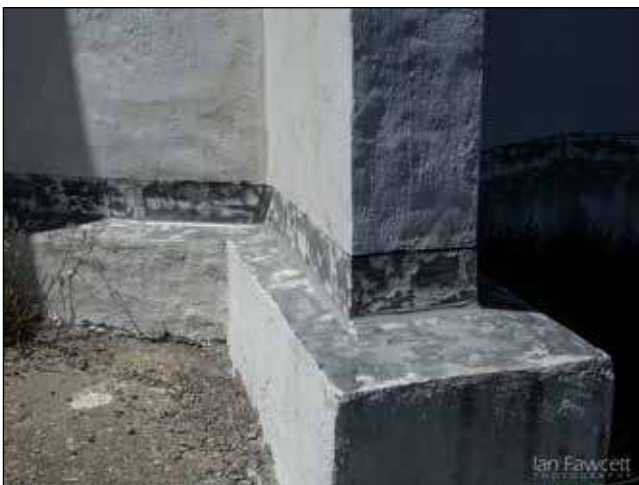
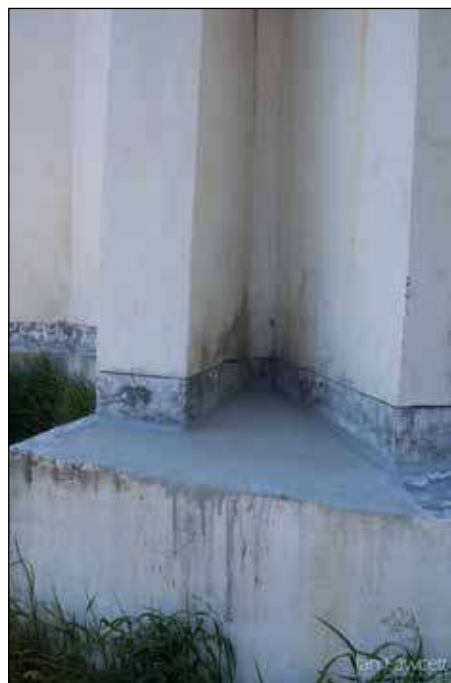
Images 100 and 101 (bottom row): water-proofing around base to protect from splash-back

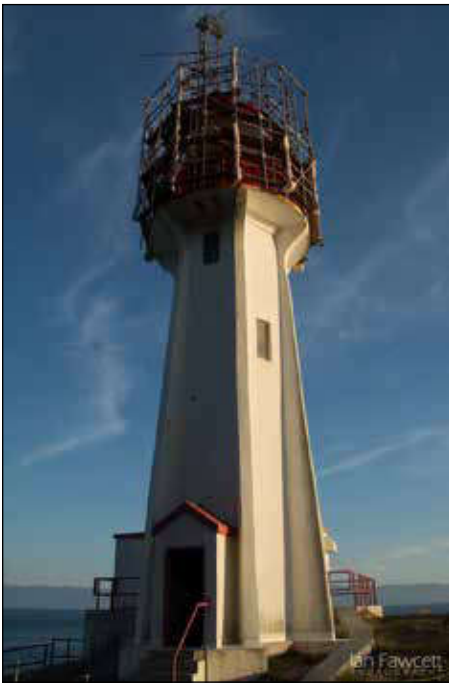
Other than the staining from the rust running down from the lantern room, there were only a few small spots that could be found (by visible examination) where the paint had chipped or blistered, nor could any significant areas be seen of concrete degradation. It was felt that only minor repair work would be needed, and that the existing paint did not need to be removed, but could remain as a substantive base.

Image 102 (top left): pre-painting condition, showing staining at top, along buttresses and around base

Each of the six sections of the hexagonal lighthouse (i.e. the column between two buttresses) was addressed individually – first a closer assessment for any areas of paint or concrete failure, and then patching as necessary, followed by application of a sealer coat and a top coat of paint. Deckcote EXT paint was used for the tower exterior (colour white). The cradle was then relocated to the next section and the process repeated.
