SHERINGHAM POINT LIGHTHOUSE

RESTORATION
2015 - 2019

Final Report
&
Documentation

Sheringham Point Lighthouse
Preservation Society

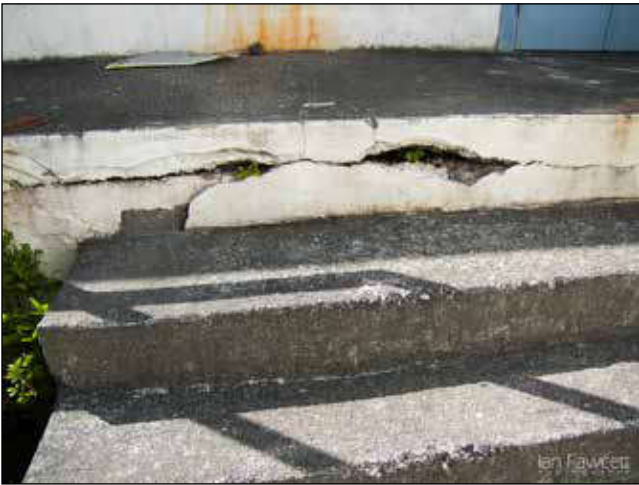
One area of specific concern was the stairs leading up to the engine room. These stairs were cracked and required repair. However, and more significantly the three stairs were not at consistent heights, as would normally be expected for stairs, but each was a different height. The height of the top step was greater than would normally be found in any functional staircase. This was felt to be a safety hazard (although minor).

Images 108, 109 (previous page and 110 (top left): showing cracking and crumbling in concrete base and stairs of engine room

Consideration was given to removing and rebuilding the stairs. However this would be an interference with one of the character defining elements of the site (the intact structural form), and so was rejected as an option. Consideration was also given to adjusting the heights of the stairs by adding a thin layer of concrete (of varying depth) over the existing stairs, to even out the heights of the steps. Again, this was considered to be changing (albeit only slightly) the character of the structure, and so it was decided simply to repair the cracks and leave the heights of the steps as they were.

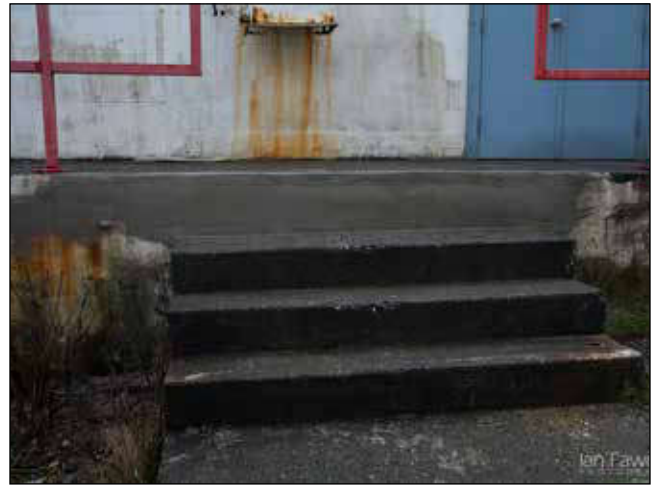
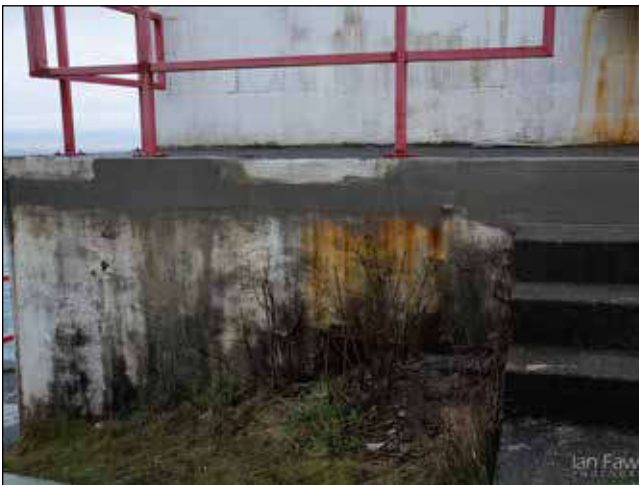
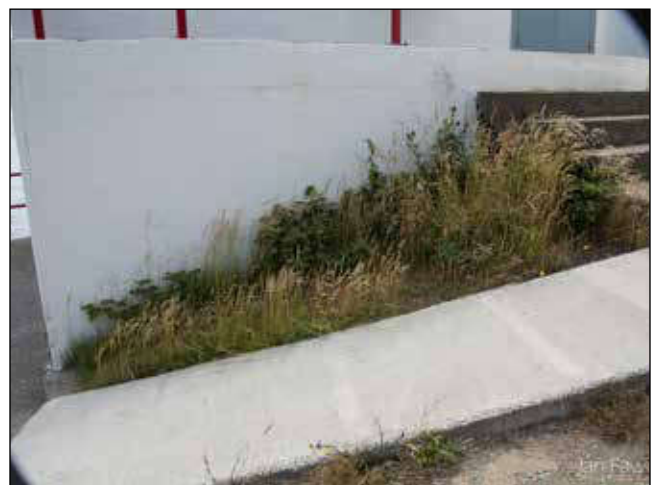
Image 111 (top right), 112 and 113 (bottom row): concrete surface restored

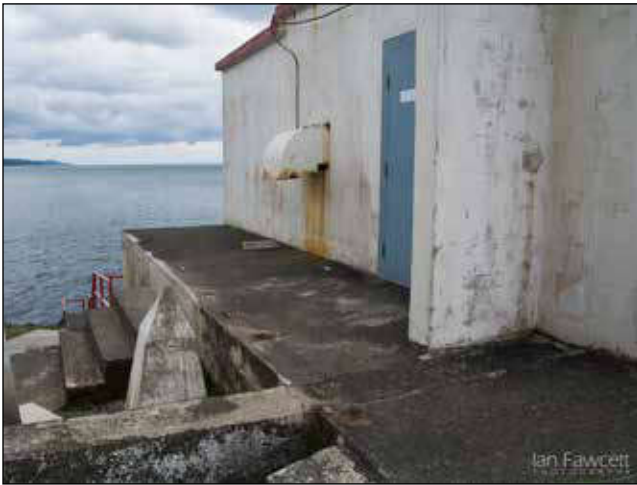
The exterior paint on the engine room was significantly weathered, patchy and flaking in a number of areas. It was scraped for preparation, and the old rusted conduit removed. A base coat and two top coats of paint were applied (same specifications as for the tower). The walls were painted white, and the roof was painted red, and the door painted deck grey.

Images 114, 115 (top row) and 116 (centre left): show paint condition on walls, roof and base

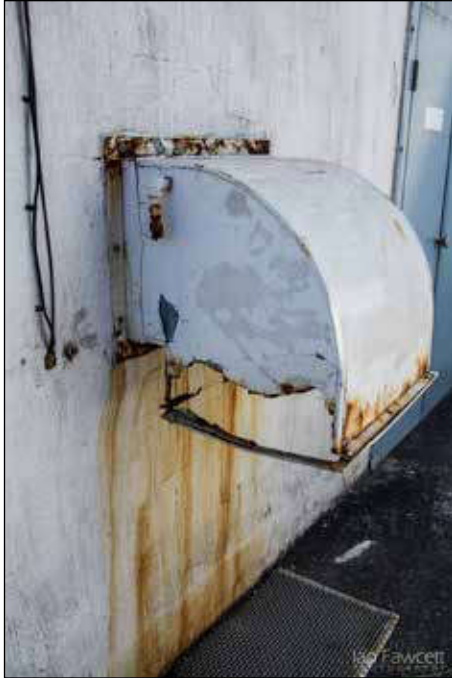
An air vent hood attached to the north wall of the engine room was seriously corroded, with parts of it completely eaten away. Also the metal brackets that attach it to the wall opening were seriously corroded, beyond repair. The vent hood was removed and taken to Foggy Mountain Forge, where a replica hood and mounting brackets were manufactured. The hood new hood was installed, and then painted. (See following photographs).

Images 120 (left): vent hood showing extensive corrosion damage

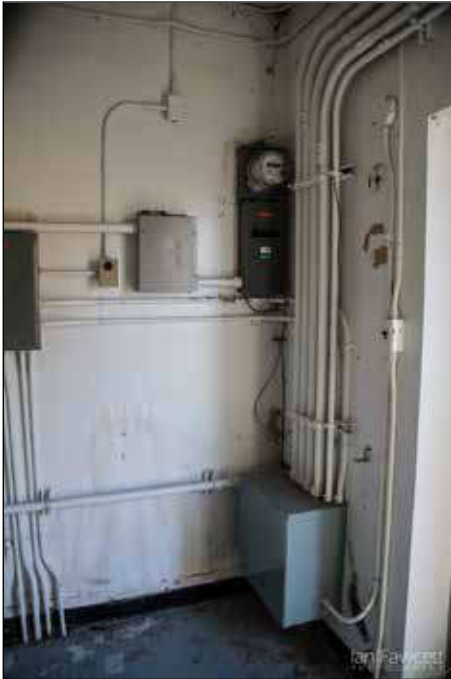
The interior walls, ceiling and floor were all showing wear, but not severe in most places. The main issue was the presence of black mould at several locations on the walls of both the main and back rooms. This was noted to have grown considerably in the past year, and is attributed to the lack of heat in the building during the past number of years. Especially in winter, the interior of the building is cold and damp. The damp had also caused the paper surface of the wallboard to wrinkle in some locations in the main room.

Images 122 (top left) and 123 (bottom left):: showing condition of interior walls and floor - note mould in corner and wrinkling along bottom

With respect to the wallboard, it was determined that the damage was restricted to the surface, and could be repaired with sanding and re-sealing, rather than removing and replacing the wallboard. Accordingly the walls were sanded, and a coat of sealer applied, followed by primer and a topcoat.

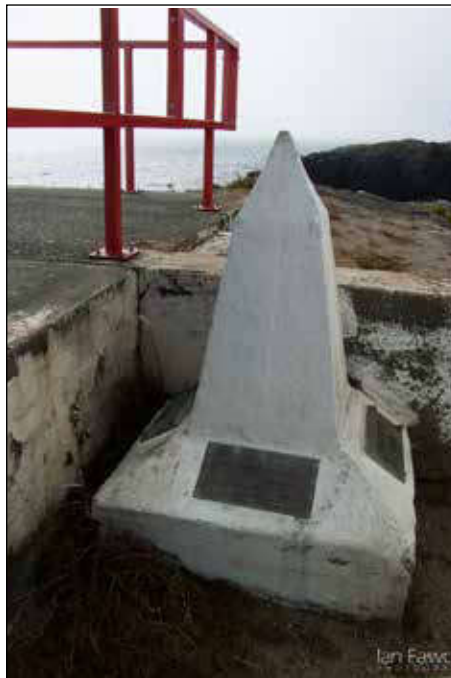
The reference marker, which is located between the engine room and the tower, marks the location of the Canada-Us boundary. Its condition was good but getting worn, so it was decided to give it a coat of paint for protection. (See following photographs).

Image127 (left): reference marker prior to painting

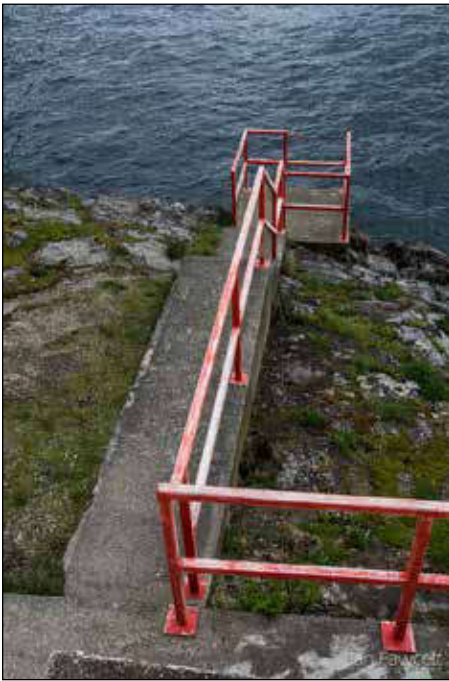
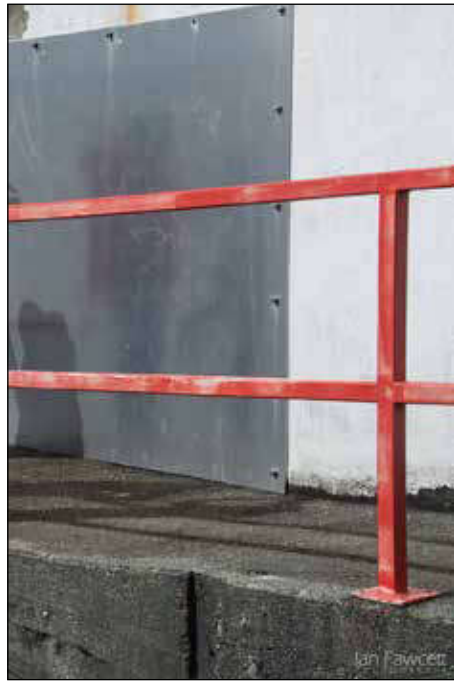
Images 131 and 132 (top left and centre): condition of remaining rails

The railings running down to and around the lookout platform, however, could not be removed without significant damage, as they were cemented in to the concrete pathway/platform. Accordingly, they were cleaned on site, through hand-grinding, and then given a coat of primer/sealer and two top coats of Amerlock (red).

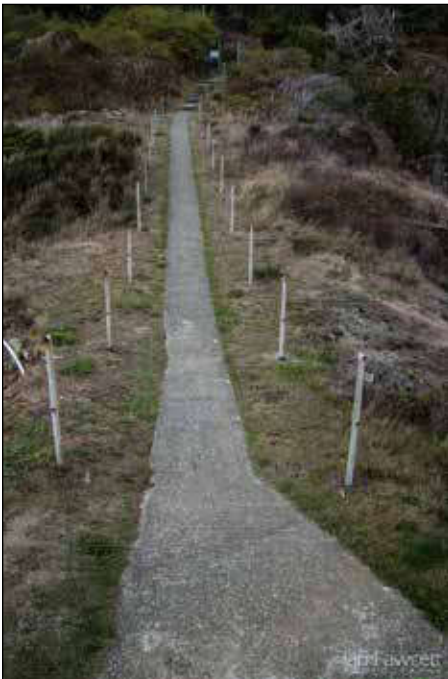
In addition, four of the required stanchions had been lost over the years, and these were replaced with new stanchions of the same size and design. (See following photographs).

Image 137 (left): pathway and stanchions, in original location and without chain rails

With the number of seniors (and others with mobility challenges) now using the site, the need for handrails to assist in accessing the lighthouse and (particularly) returning up the relatively steep pathway was critical. It was decided to relocate the stanchions on the east side of the pathway so that they would be within reach of the pathway users.

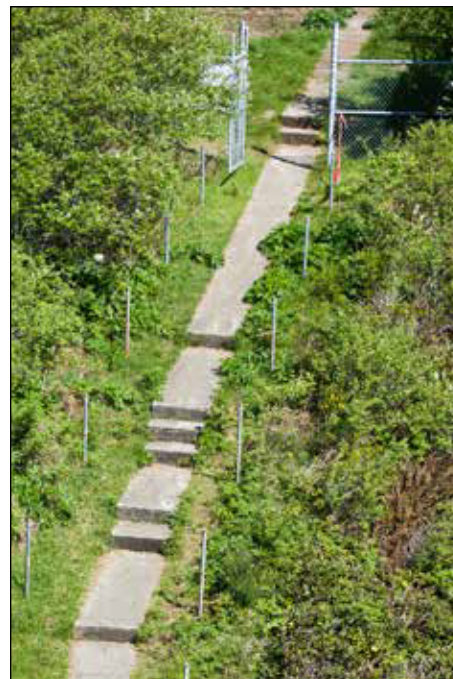
The concrete pathway was constructed in the mid 1960s by lightkeeper Jim Bruton. Accordingly it was deemed to be a significant historical feature, and as such it was decided that no changes should be made to it. There are nine steps, in groups of 1, 2 or 3, along the path, which are mostly non-standard heights. Also one of steps is not at right angles to the rise, but slopes downward at about 70 degrees. All of these steps pose a hazard. However, it was decided to leave the pathway as is (as historical fabric), as it was felt the relocation of the handrail would compensate in large part for the hazard. It is recommended that this continue to be monitored (especially the sloping step), and if necessary to install a small caution sign by the step (located on the adjacent stanchion).

Image 141 (right): showing steps on pathway; unlevel step is 2nd from bottom

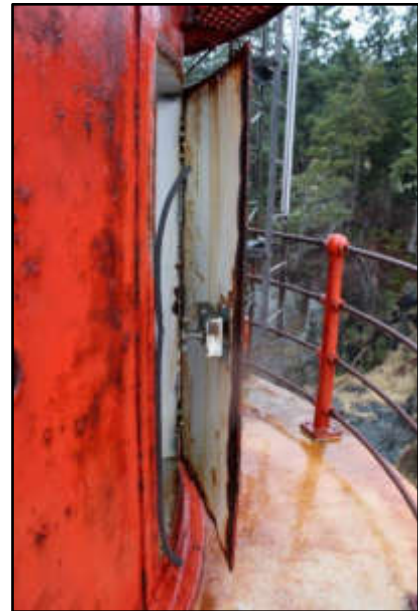
Corrosion was observed on the lower structure of the lantern room, both on the exterior surface of the cast iron wall panels and along the exposed edge of the door as well as its interior surface (*see photograph 4*). The interior surface of the remaining wall panels appeared in good condition with no observed signs of corrosion. The condition of the door appears related to the fact that it can no longer be closed tight, resulting in a gap that allows moisture ingress around its perimeter. The door hinges and closure hardware both appear to be in good condition.

Photograph 4 – Corroding cast iron wall panel and door

Table 1 – Recommended Renewals		
A	Remove corrosion from the cast iron panels and repaint the damaged surfaces.	2-3 yrs
B	Restore the cast iron door, removing all corrosion and repaint the damaged surfaces. Realign the door panel to improve the tightness of closure – weather gaskets may be required.	1-2 yrs
C	Remove corrosion from the structural posts and repaint the damaged surfaces. Restore the structural integrity of the posts where necessary.	1 yr
D	Renew the damaged glass with replacement units if possible or repaired units where necessary.	1 yr
E	Patch the exterior window sealant, replacing sealant where necessary.	1-2 yrs
F	Remove corrosion from the cast iron gutter and repaint the damaged surfaces.	2-3 yrs
G	Remove corrosion from the exterior ladder and guardrail and repaint the damaged surfaces.	2-3 yrs

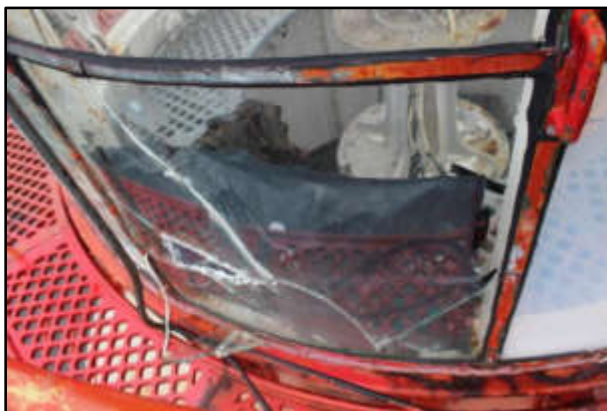
Photograph 5 – Glazed mid-section with butyl sealant applied along the astragal and cap bars

This section has the most significant damage and deterioration. Many of the glass panes are broken, noted and observed to be due to gunshot from passing boats. Past repair efforts include taping the cracks and broken pieces, sealing the cracks with sealant or taping plastic sheets over the damage. A number of east panes have also been painted red, noted to diminish the light shining into the former lightkeepers' home. This paint has started to peel away from the glass surface on a number of panes. To the exterior, a bead of butyl sealant has been applied around each glass pane to provide weather proofing against moisture ingress (see *photograph 5*). Moisture is however still 'bleeding' in at the base of the cast iron posts leading to acute localized structural corrosion (see *photograph 6*). The protective paint coating on the posts, as well as many of the astragal and cap bars is peeling away, though corrosion of any significance appeared to be limited to the cast iron posts.

The cast iron lantern room was generally found to be in fair condition. A number of elements are however experiencing signs of deterioration while a few of these elements are either nearing a level of structural concern. It is the primary recommendation that the mid-section receive priority attention at this time. The structural posts should be restored or reinforced until such a time that they can be restored while the broken glazing should be replaced or patched to produce a weathertight space to the interior. Enhancing this effort would be the renewal or repair of the glazing sealant. If the opportunity exists, the deterioration of the cast iron panels and gutter should be addressed, removing the corrosion and protecting the damaged area with a coat of paint. Ultimately, plans to renew the entire lantern room would include a full refurbishment of the cast iron structure and glazing requiring the complete removal of the existing paint, a full recoating of the cast iron elements and the full replacement of all broken glass panes, possibly with acrylic to address the recurring gunshot damage.

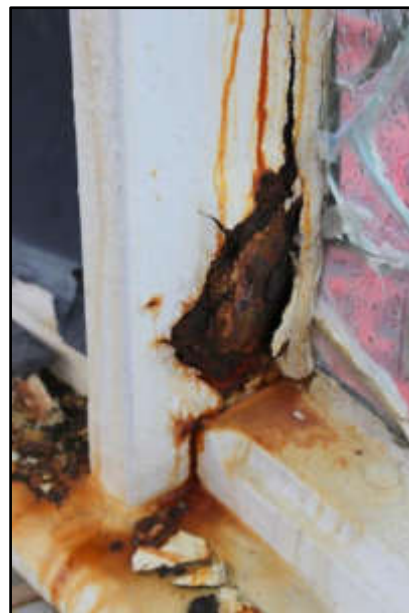
Photograph 6 – Moisture ingress and acute corrosion at the base of the support tube

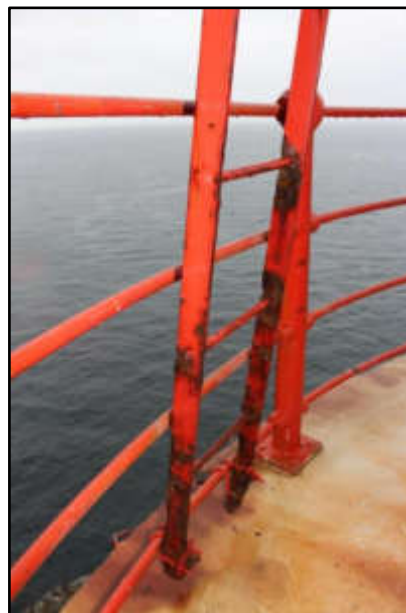
The exterior walkway appeared to be in fair condition with limited instances of corrosion including a number of damaged bolts that had been previously painted over. The guardrails were also observed to be in fair condition with only a few rails having extensive surface corrosion and a limited extent of more acute corrosion. The ladder had a number of acutely corroded zones, mostly near the base. The interior walkway and access stairs appeared in good condition with no observed signs of corrosion.

Photograph 9 – Concrete platform guardrail and roof ladder

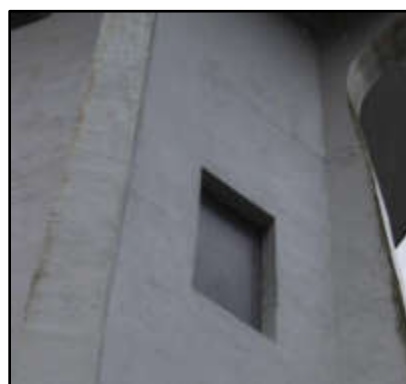
Photograph 10 – Infilled tower opening

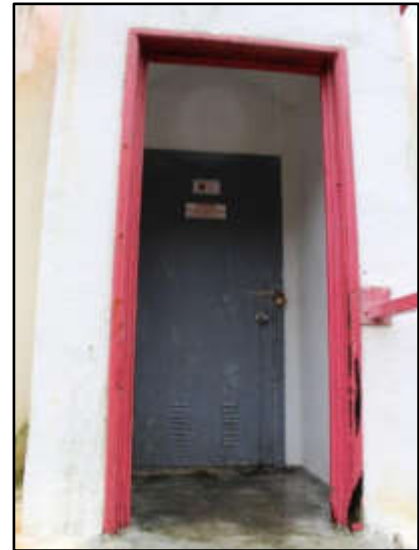
The reinforced, concrete tower appeared in good condition with few signs of deterioration beyond a number of cracks and minor spalls marked on the interior surface. It is noted that the tower has been well maintained in the past and protected with a white, elastomeric coating. A wood frame door jamb delineating the opening to the dormer is however severely decayed at the base while iron oxide staining can be seen both along the edge of the upper platform and down the walls of the dormer – both stains attributed to moisture runoff from the corroding cast iron lantern room.

Photograph 11 – Deteriorated wood frame jamb

Considering the condition of the tower and the limited deterioration, it is recommended that it be simply monitored while plans are developed to budget for future renewal works of the door frame and paint coating.

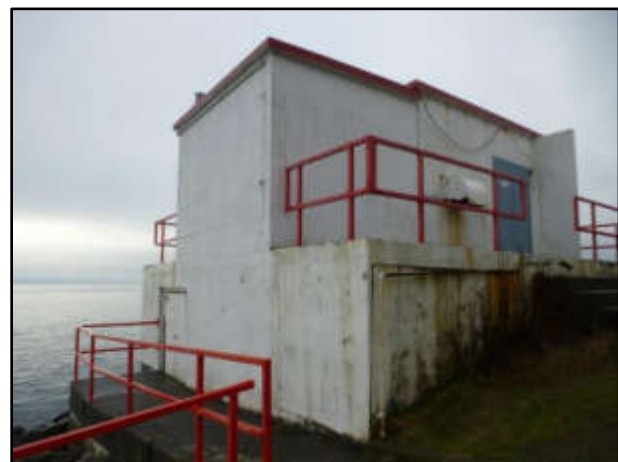
Despite being a simple concrete structure protected with just a coating of paint, only minor levels of deterioration were observed. The paint is wearing away from the concrete roof while the lower foundation has some minor spalling, staining and chipping of the paint along its exterior walls.

Photograph 12 – South-east corner of the engine room

Considering the exposure of the engine room and its current condition, it is recommended that it be simply monitored at this time while plans are developed to budget for future renewal works.

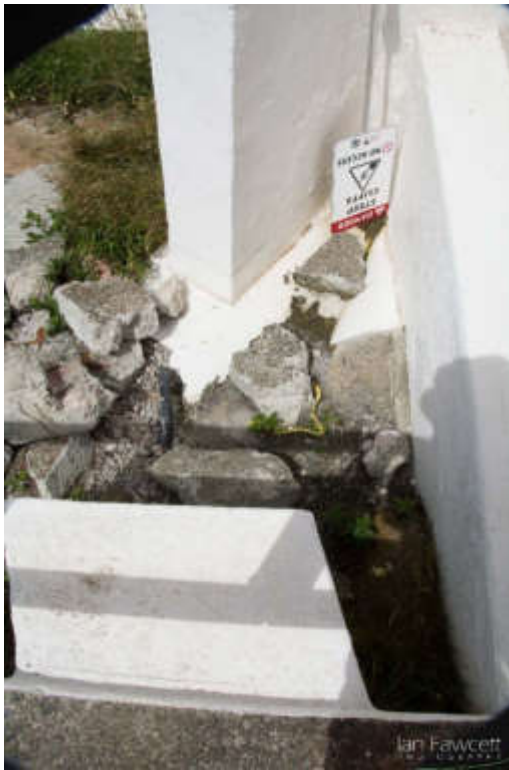
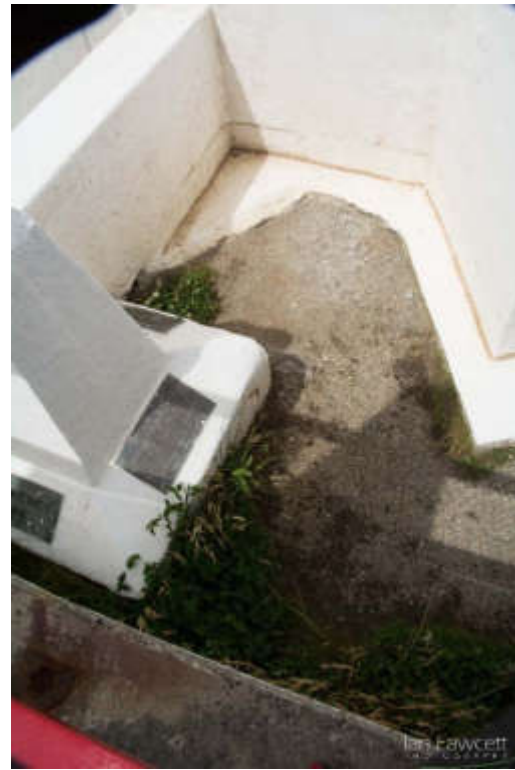
Sub Area 1 – Base of Tower: The area around the base of the tower (South and West sides) was also significantly disturbed, due to trenching, providing cable access into the engine room, and to address water ingress into the tower. (See photographs below). Previously, these areas were grassed.

The area to the west of the tower should be re-sodded.

The area to the southwest of the tower requires additional concrete to be added to change the topography slightly to prevent pooling of water immediately adjacent to the tower wall. Debris also needs to be removed. It can then be re-sodded, or levelled with a layer of gravel (above a weed barrier) – at the discretion of the Site Manager.

The area to the southeast of the tower should be re-sodded, or levelled with a layer of gravel (above a weed barrier) – at the discretion of the Site Manager.
